# Repair of HP83651A Sweeper for an HP8510C VNA System

Prof. Dr. Thomas Baier  
DG8SAQ

June, 2026

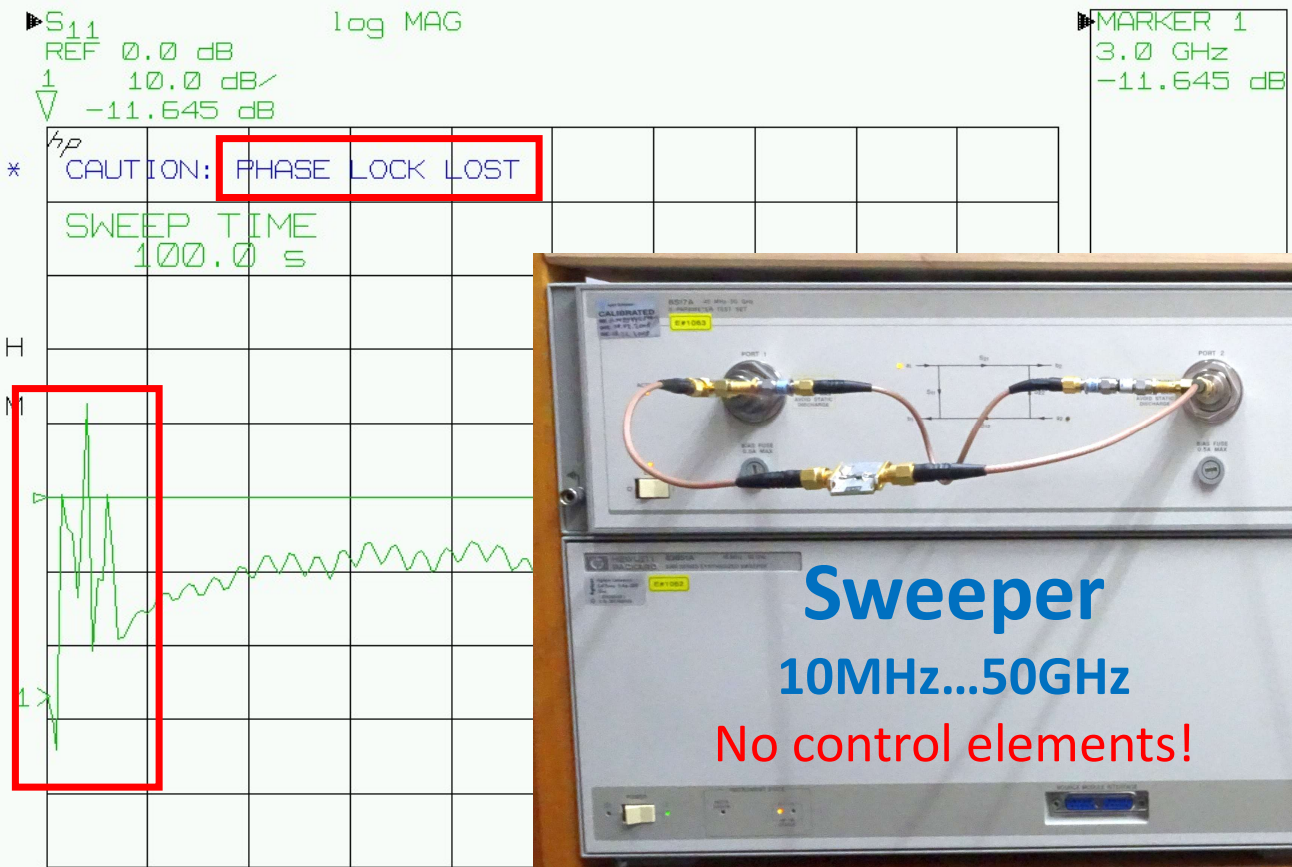
Low frequency HP8510C Sweep => Phase Lock Lost!

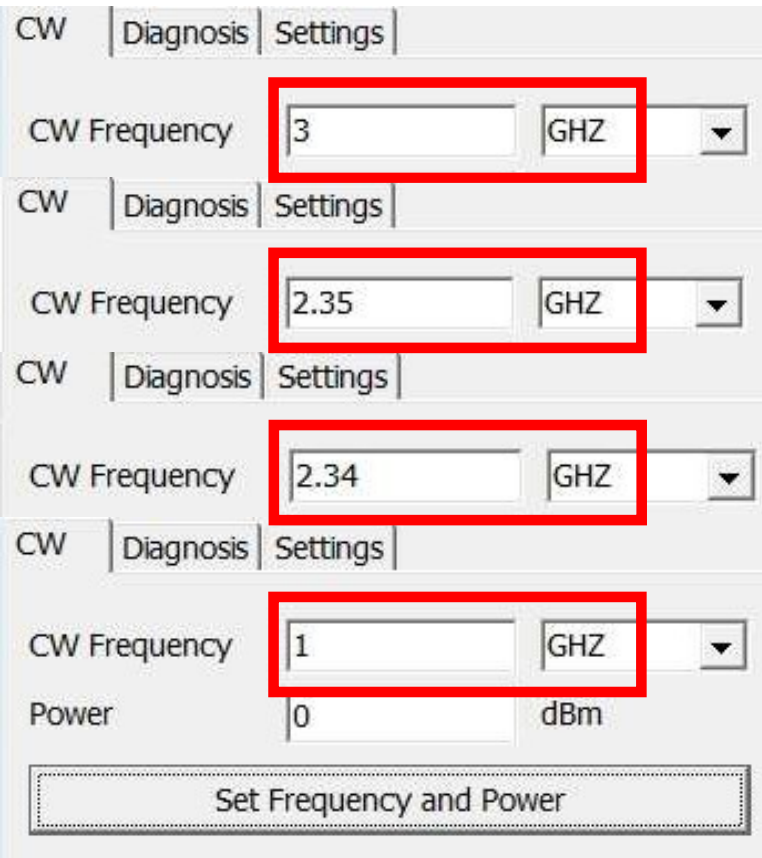
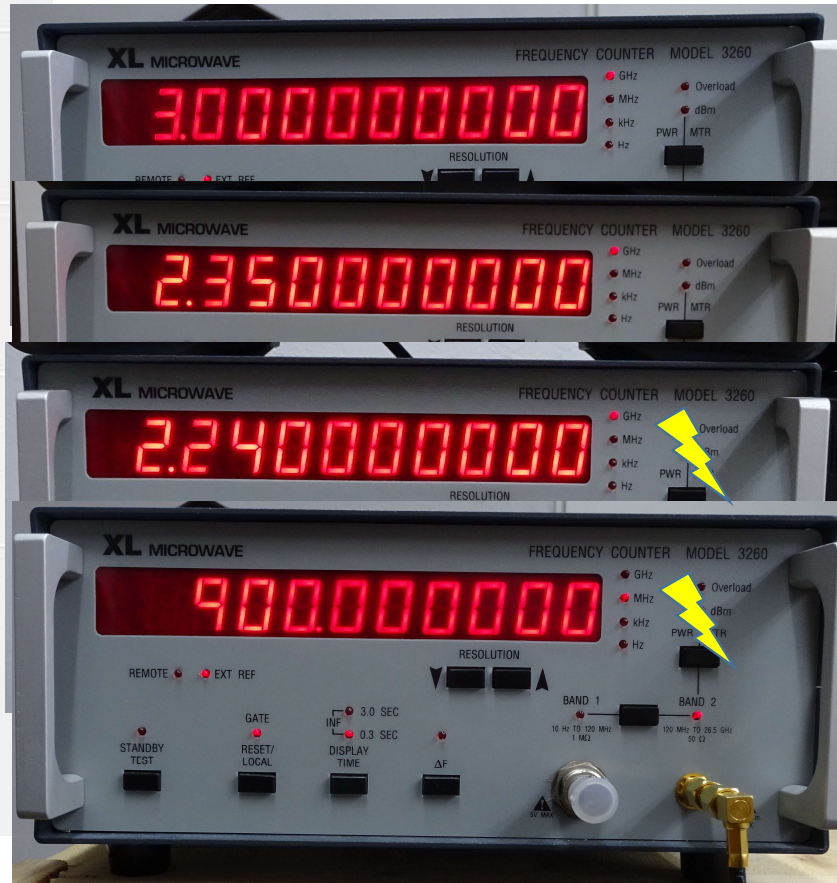
- Sweeper works correctly at 2.35GHz and above
- Below 2.35GHz output frequency is ***exactly 100MHz too low***

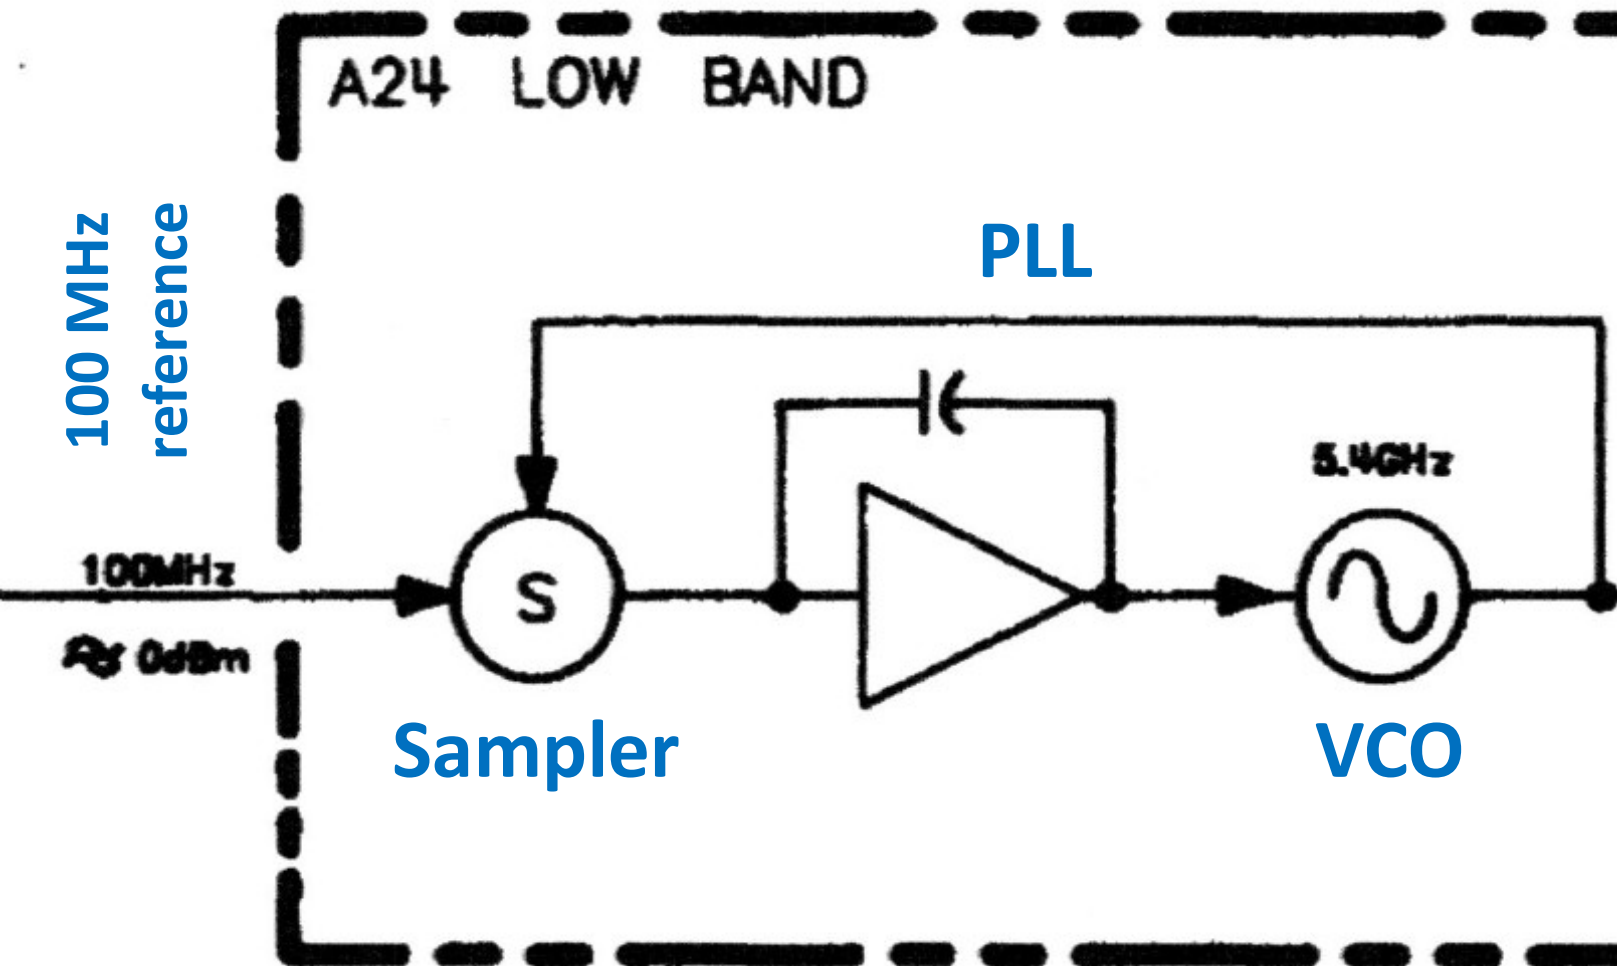
# Block Diagram Low-Band Module

- 5.4GHz VCO locking to wrong harmonic of 100MHz reference
- No schematics
- Not serviceable

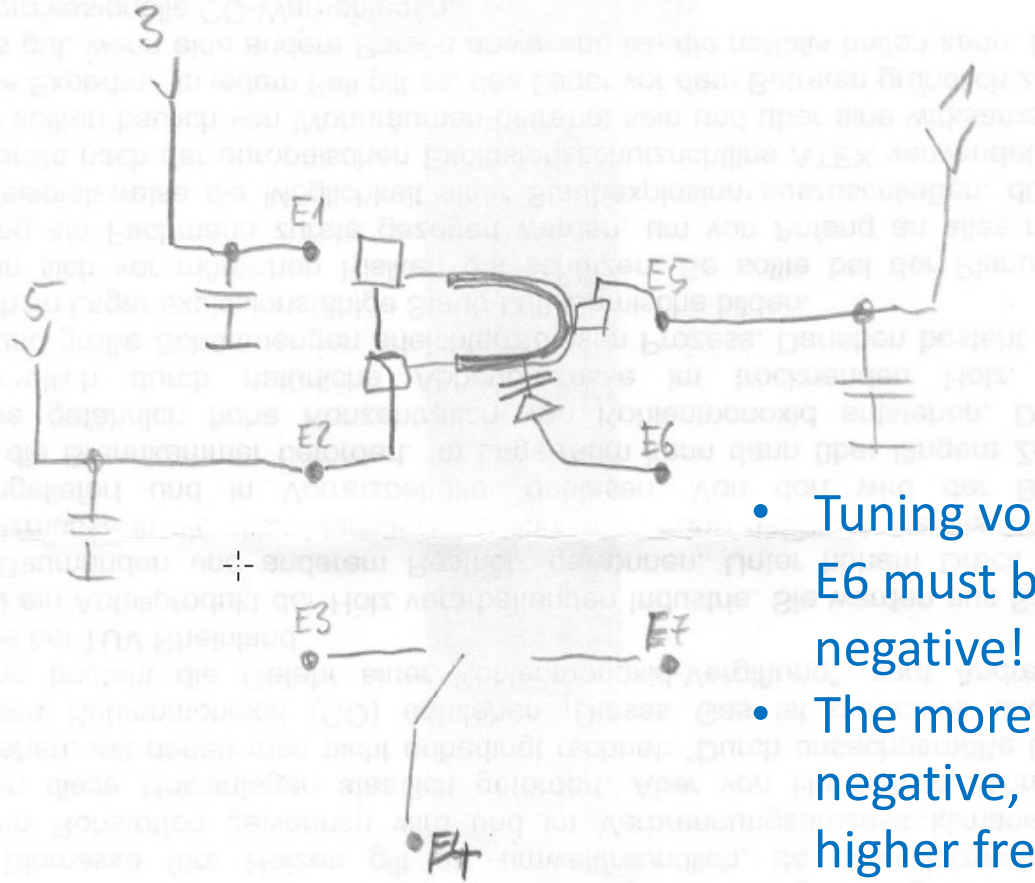
# VCO

- Tuning voltage on E6 must be negative!
- The more negative, the higher frequency

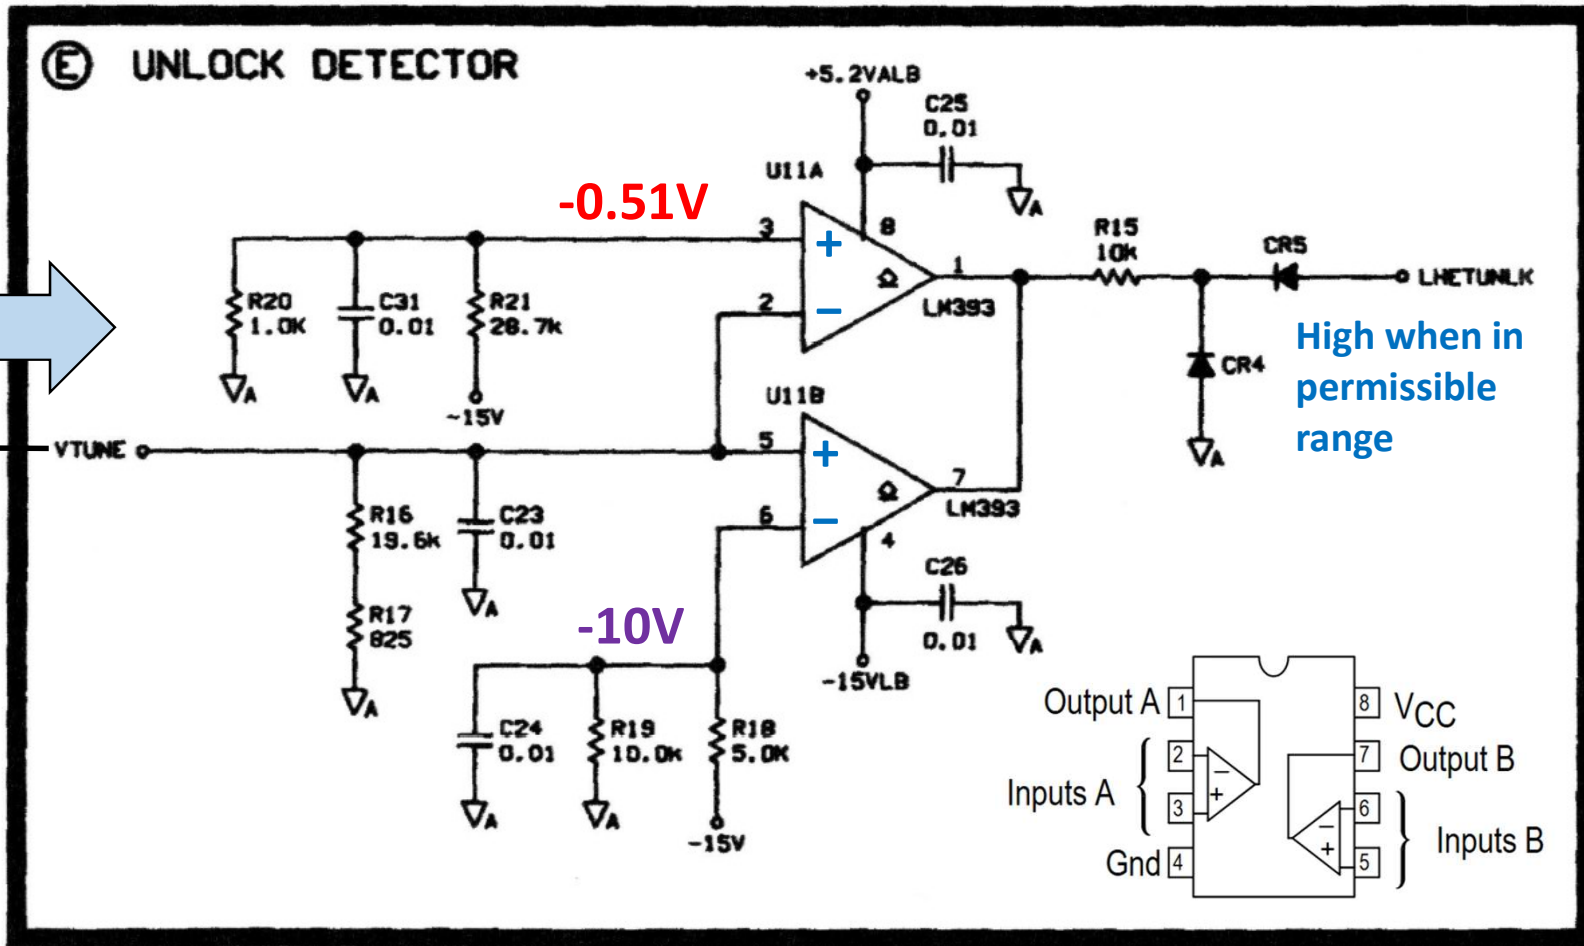
# VCO Unlock Detector

Presents load of 71,4 kΩ for VCO tuning voltage

OK, when  $-35V < V_{VCO} < -1,8V$   
 $V_{VCO}$  must be negative!!!

268.000) RF : LOBAND Tuning Voltage : V-Tune [mV]	actual	min.	max.
My unit: $-6,75V/3,5=-1,93V$	-3675	-11000	-400

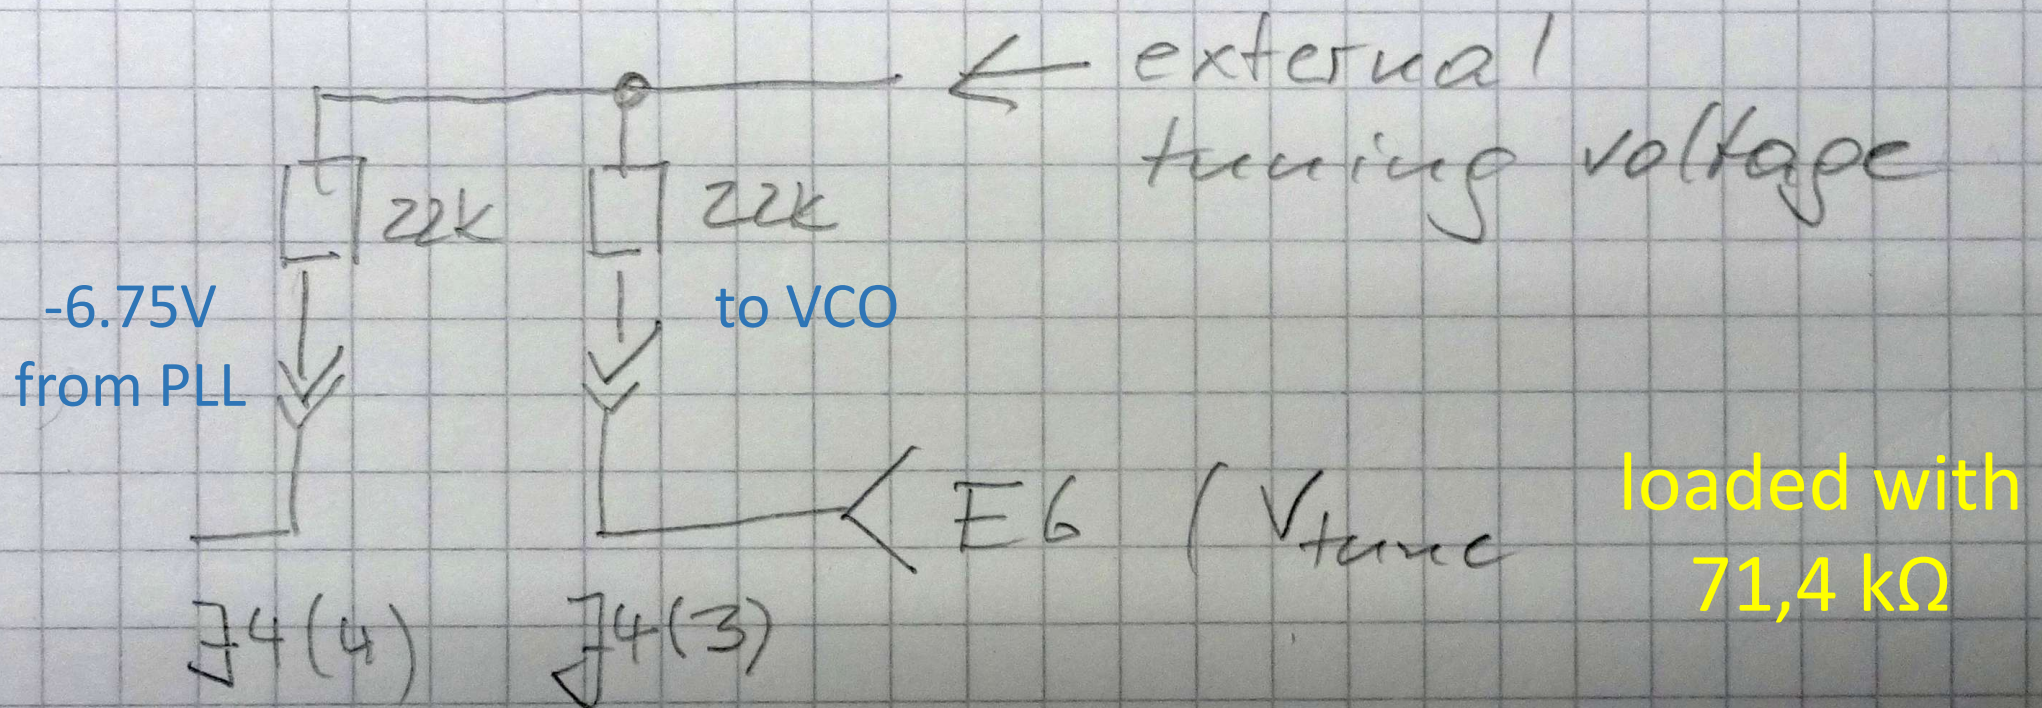
## Troubleshooting (2)

$$\text{nominal } f_{VCO} = 5,4 \text{ GHz}$$

$$\text{YIG } 6 \text{ GHz} \Rightarrow \text{RF} = (6 - 5,4) \text{ GHz} = 600 \text{ MHz}$$

$$\text{actual output at } 600 \text{ MHz nominal} = 500 \text{ MHz}$$

$$\Rightarrow 500 \text{ MHz} = 6000 \text{ MHz} - f_{VCO}$$

$$\Rightarrow f_{VCO} = 6000 \text{ MHz} - 500 \text{ MHz} = 5500 \text{ MHz} = 5,5 \text{ GHz}$$

$\Rightarrow$  VCO oscillates 100 MHz too high!

$\Rightarrow$   $V_{tune}$  is too low!

i.e.  $V_{VCO}$  is too negative at -6.75V

- VCO micro-module is broken, likely varactor diode bias problem
- VCO can still be tuned to correct frequency at zero varactor current
- Output power still correct

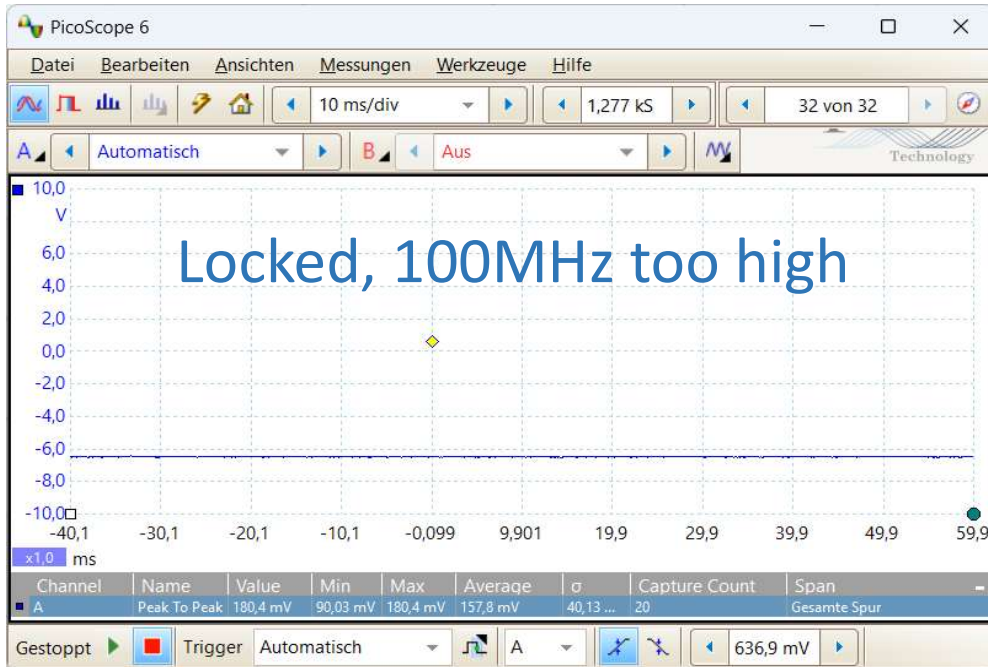
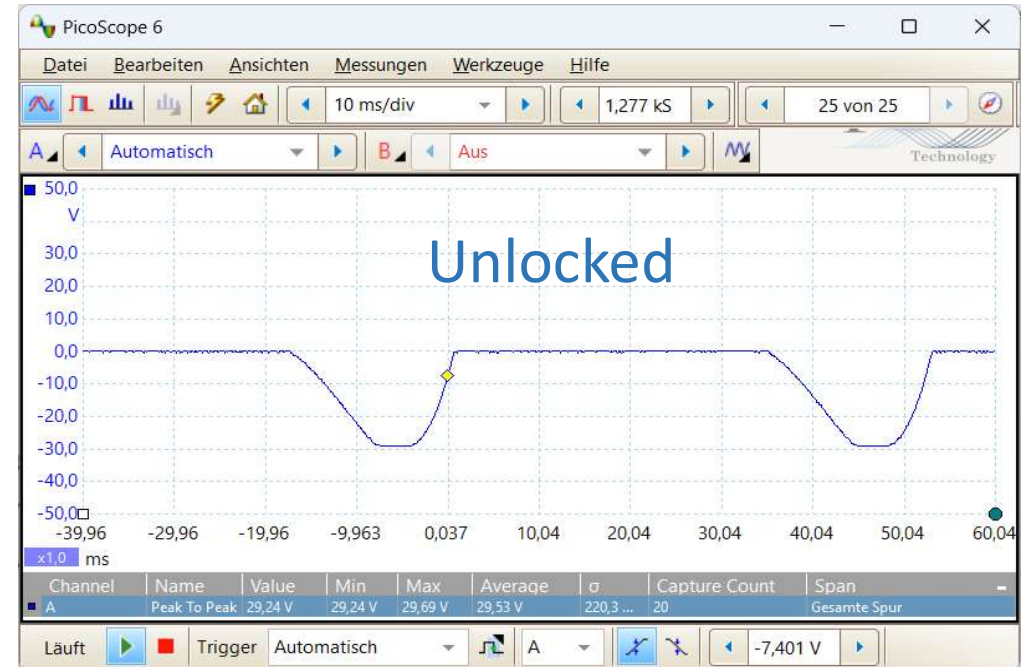
## Output voltage of PLL circuit at J4 (4)

- PLL voltage oscillates at 20Hz if NOT locked ← positive feedback!!!
- $-30V < V_{PLL} < 0V$  under all conditions
- If NOT locked, tuning voltage must sweep through lock condition!

- Shift VCO tuning voltage to +6.9V for locking to correct harmonic
- Make sure VCO tuning voltage never comes close to -6,5V or + 11.3V to prevent locking to wrong harmonic
- Varactor starts leaking at +8,6V, so better keep  $V_{\text{tune}}$  below +8V
- Keep PLL output voltage in permissible range  $-35\text{V} < V_{\text{tune}} < -1,8\text{V}$  to trick lock detector

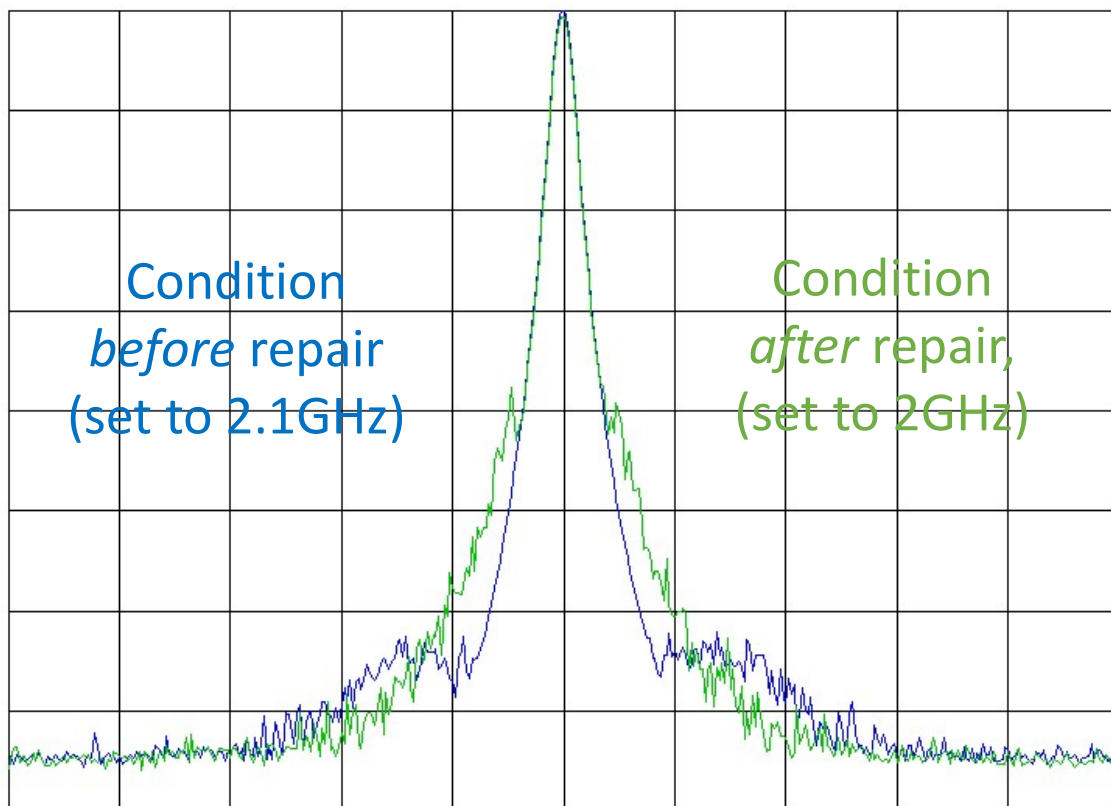
# Some Drawback

Condition  
*before repair*  
(set to 2.1GHz)

Condition  
*after repair,*  
(set to 2GHz)

Phase Noise has  
suffered, but still good  
enough for VNA work!
