Adventure Microwave-VNA: Repairing and Operating an HP8510

Prof. Dr. Thomas Baier
DG8SAQ

My Deram: HP8510 – 26,5GHz VNA

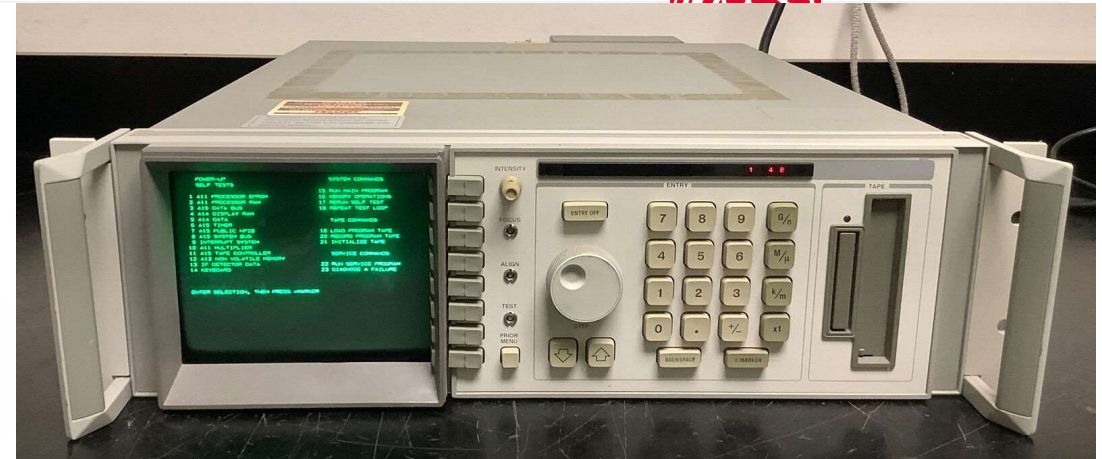
HP85101 Display/Processor

- Display
- Processor
- Data Storage
- GPIB-Interface

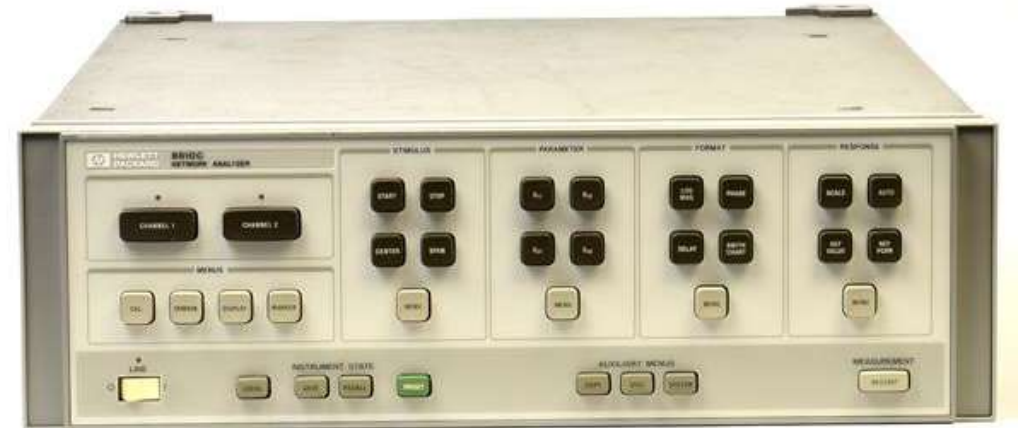
HP85102 Receiver Backend

- IF-Unit
- ADC
- PLL

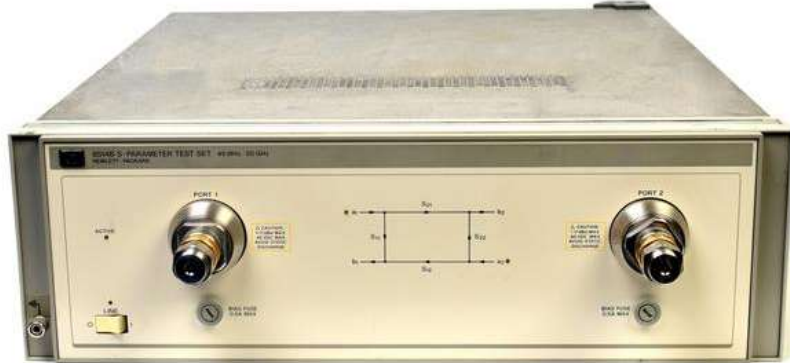
HP8514/8515/8516 Test Set

- Bridges
- RF-Switch
- 1st Mixers/Samplers
- LO

HP8514: 45MHz-20GHz
 HP8515: 45MHz-26,5GHz
 HP8516: 45MHz-40GHz

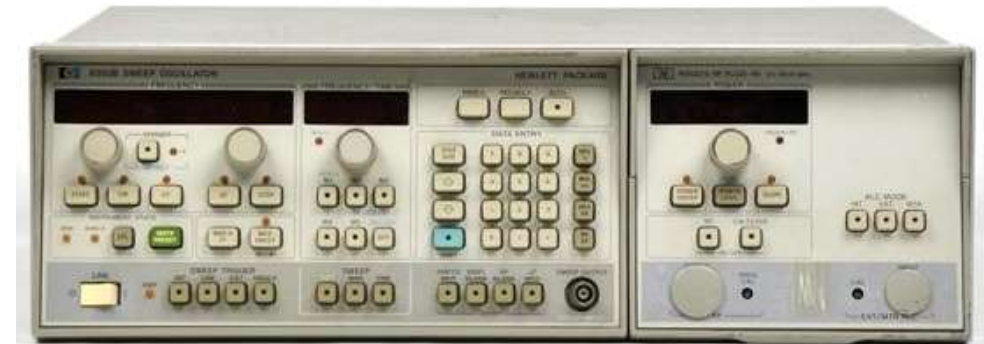
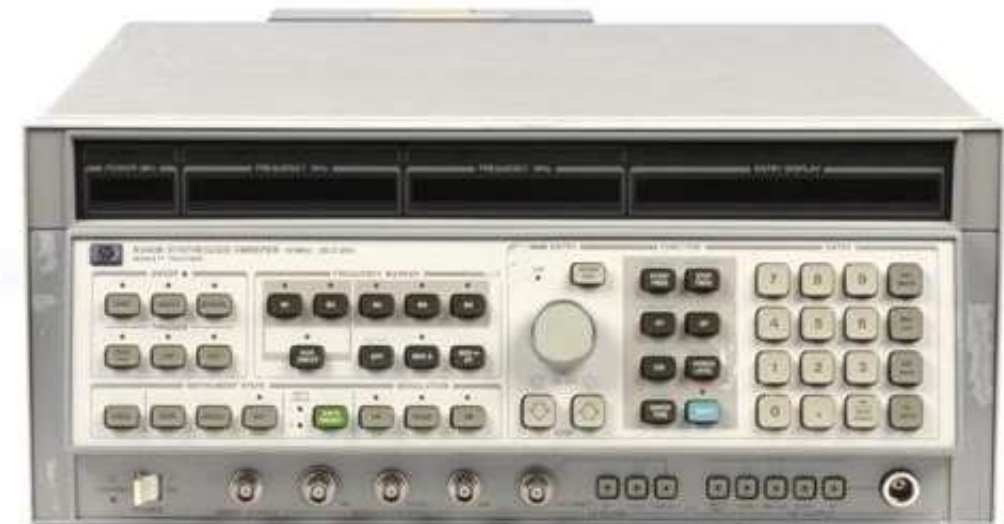
HP8350B

- Free Running Sweeper
- 10MHz-26,5GHz
(depending on Plug-in)

HP8340 / HP8341

- PLL Sweeper

HP8340: 10MHz-26,5GHz

HP8341: 10MHz-20GHz

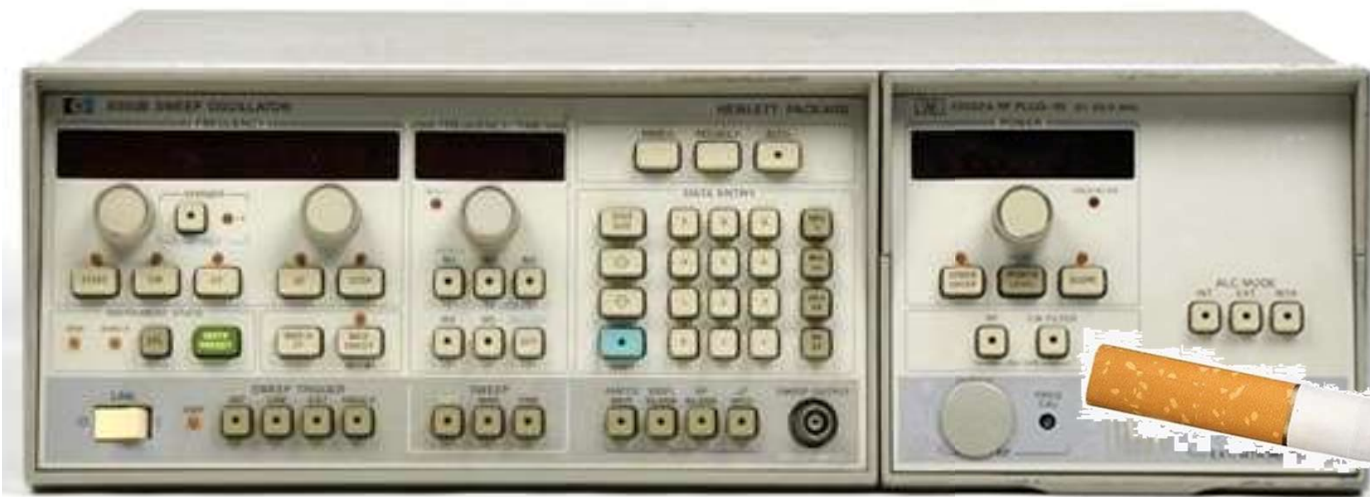
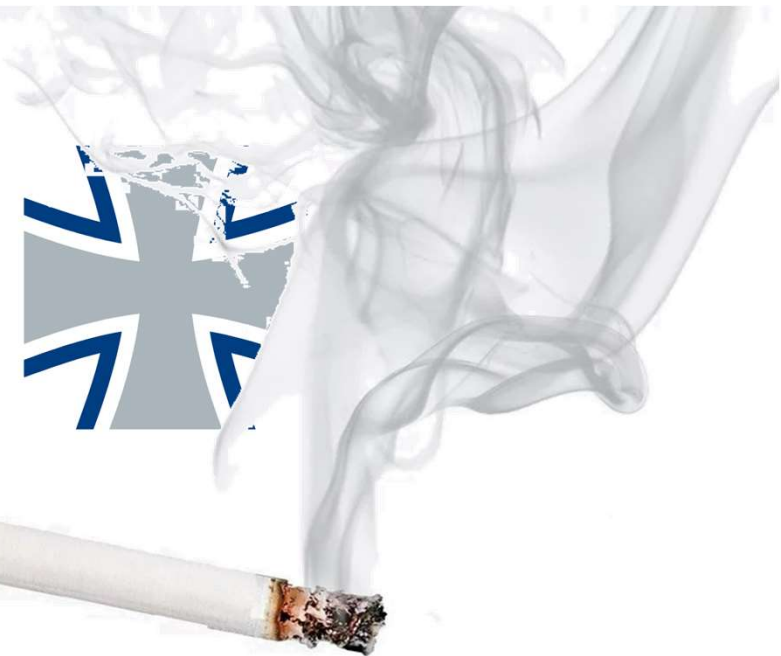
- HP 8350B / HP 83592A - Sweep Generator 10 MHz - 20 GHz
- From Ebay, ex German Army
- € 1249,-
- *Chain Smoker*

Testing Generator on 6GHz Bandpass Filter using Diode Detectors and Directional Coupler

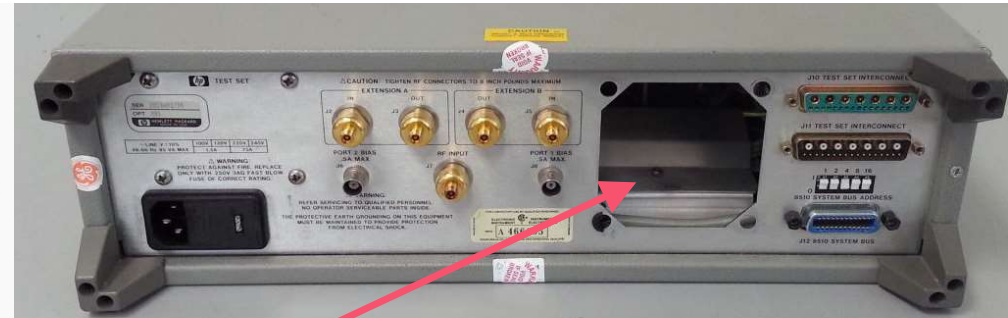
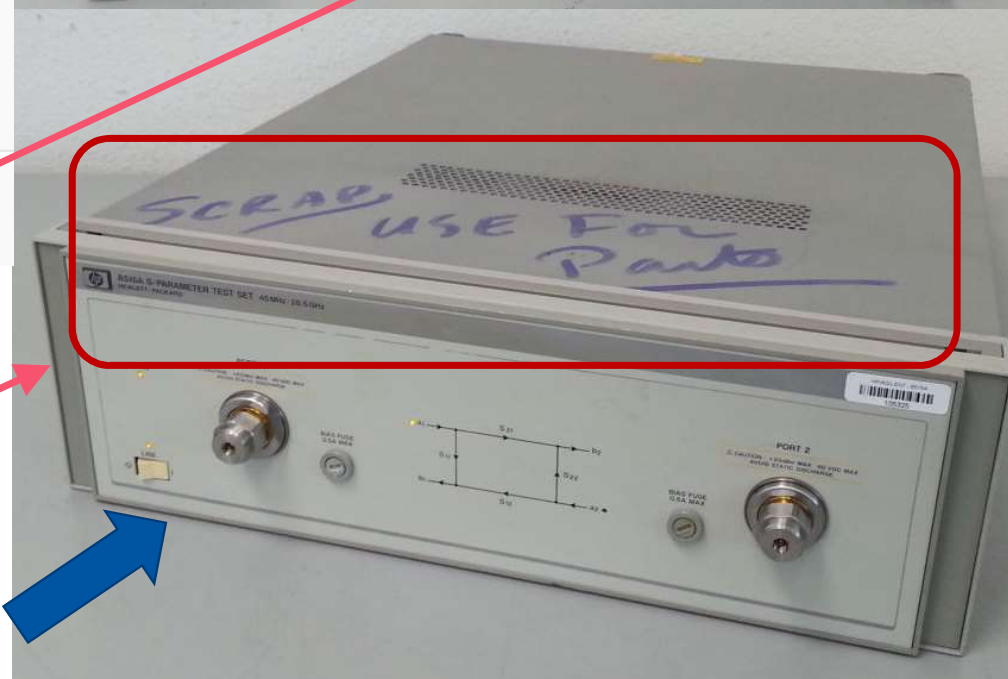
HP8515A 26,5GHz Test Set

- ... + Transport + Tax
- Fan missing
- Hopefully good investment

This is where all the RF magic happens!

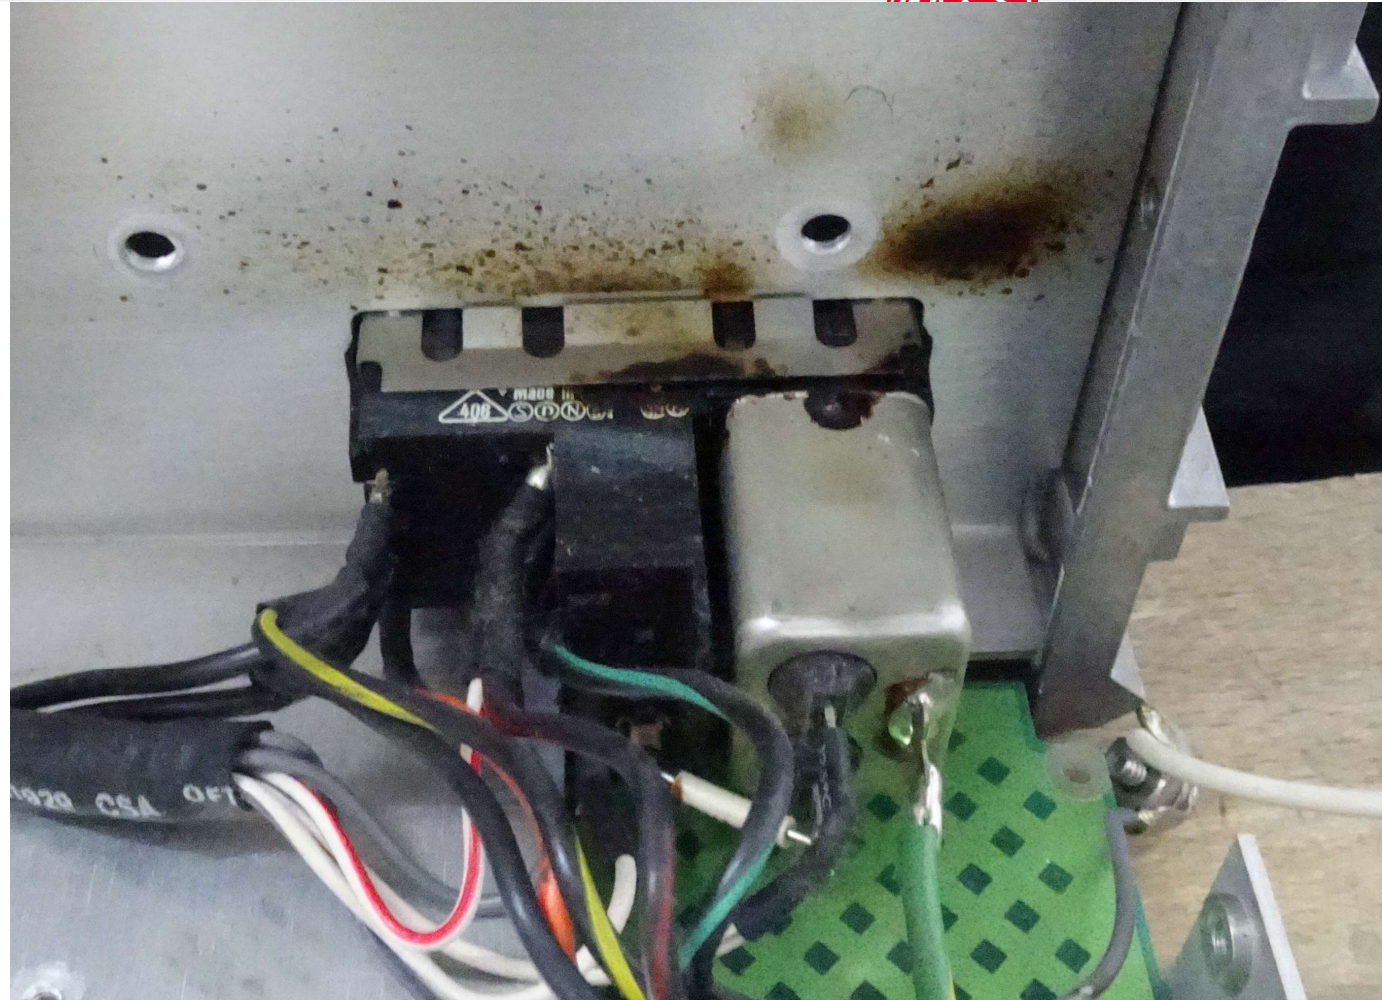
- New fan mounted
 - Mains selector to 230V
 - Power-up, 10min later...
- ➔ **Smoke and Stink!**

*X-Capacitor in mains filter
went up in smoke! ☹️*

Mains filter difficult to reach...

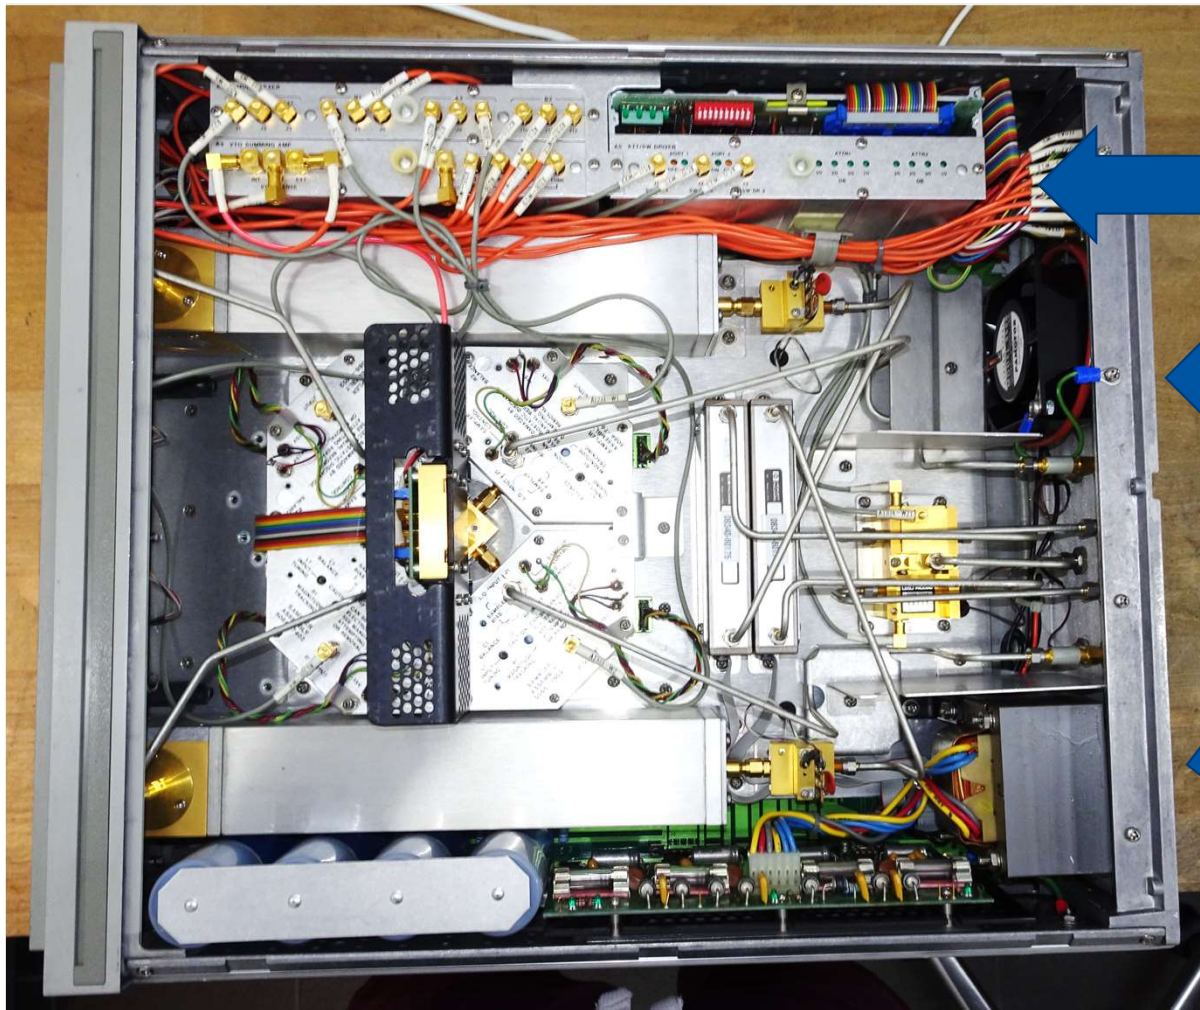
Swap of Mains Filter in HP8515A (1)

- Remove all cables
- Remove back panel

Mains filter
between
transformer and
motherboard...

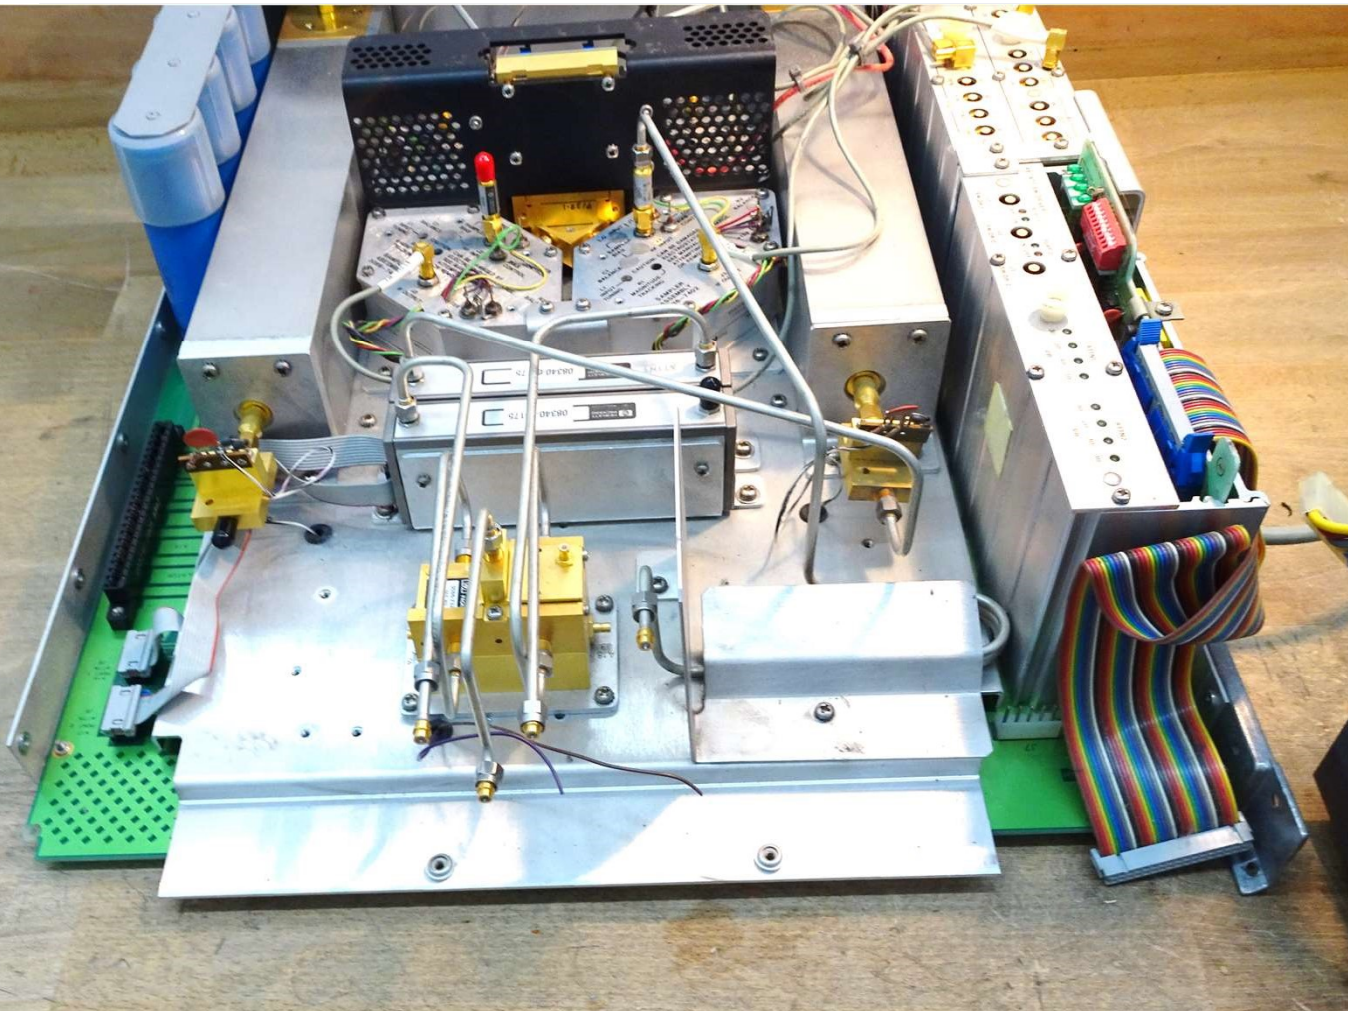
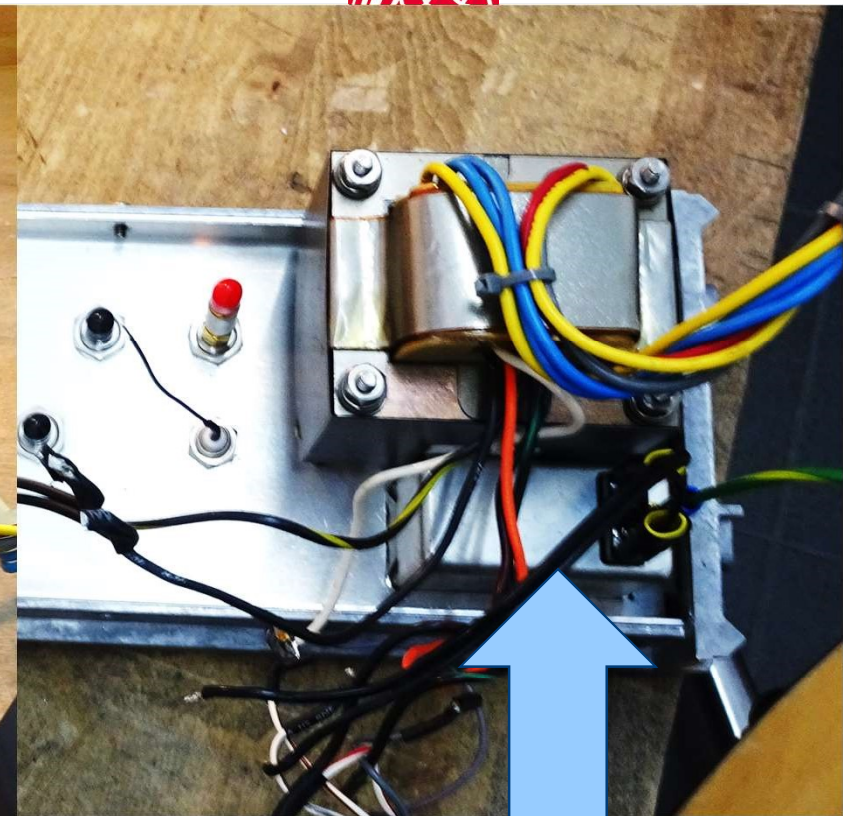
Swap of Mains Filter in HP8515A (3)

NEW! 😊
But only for 230V!

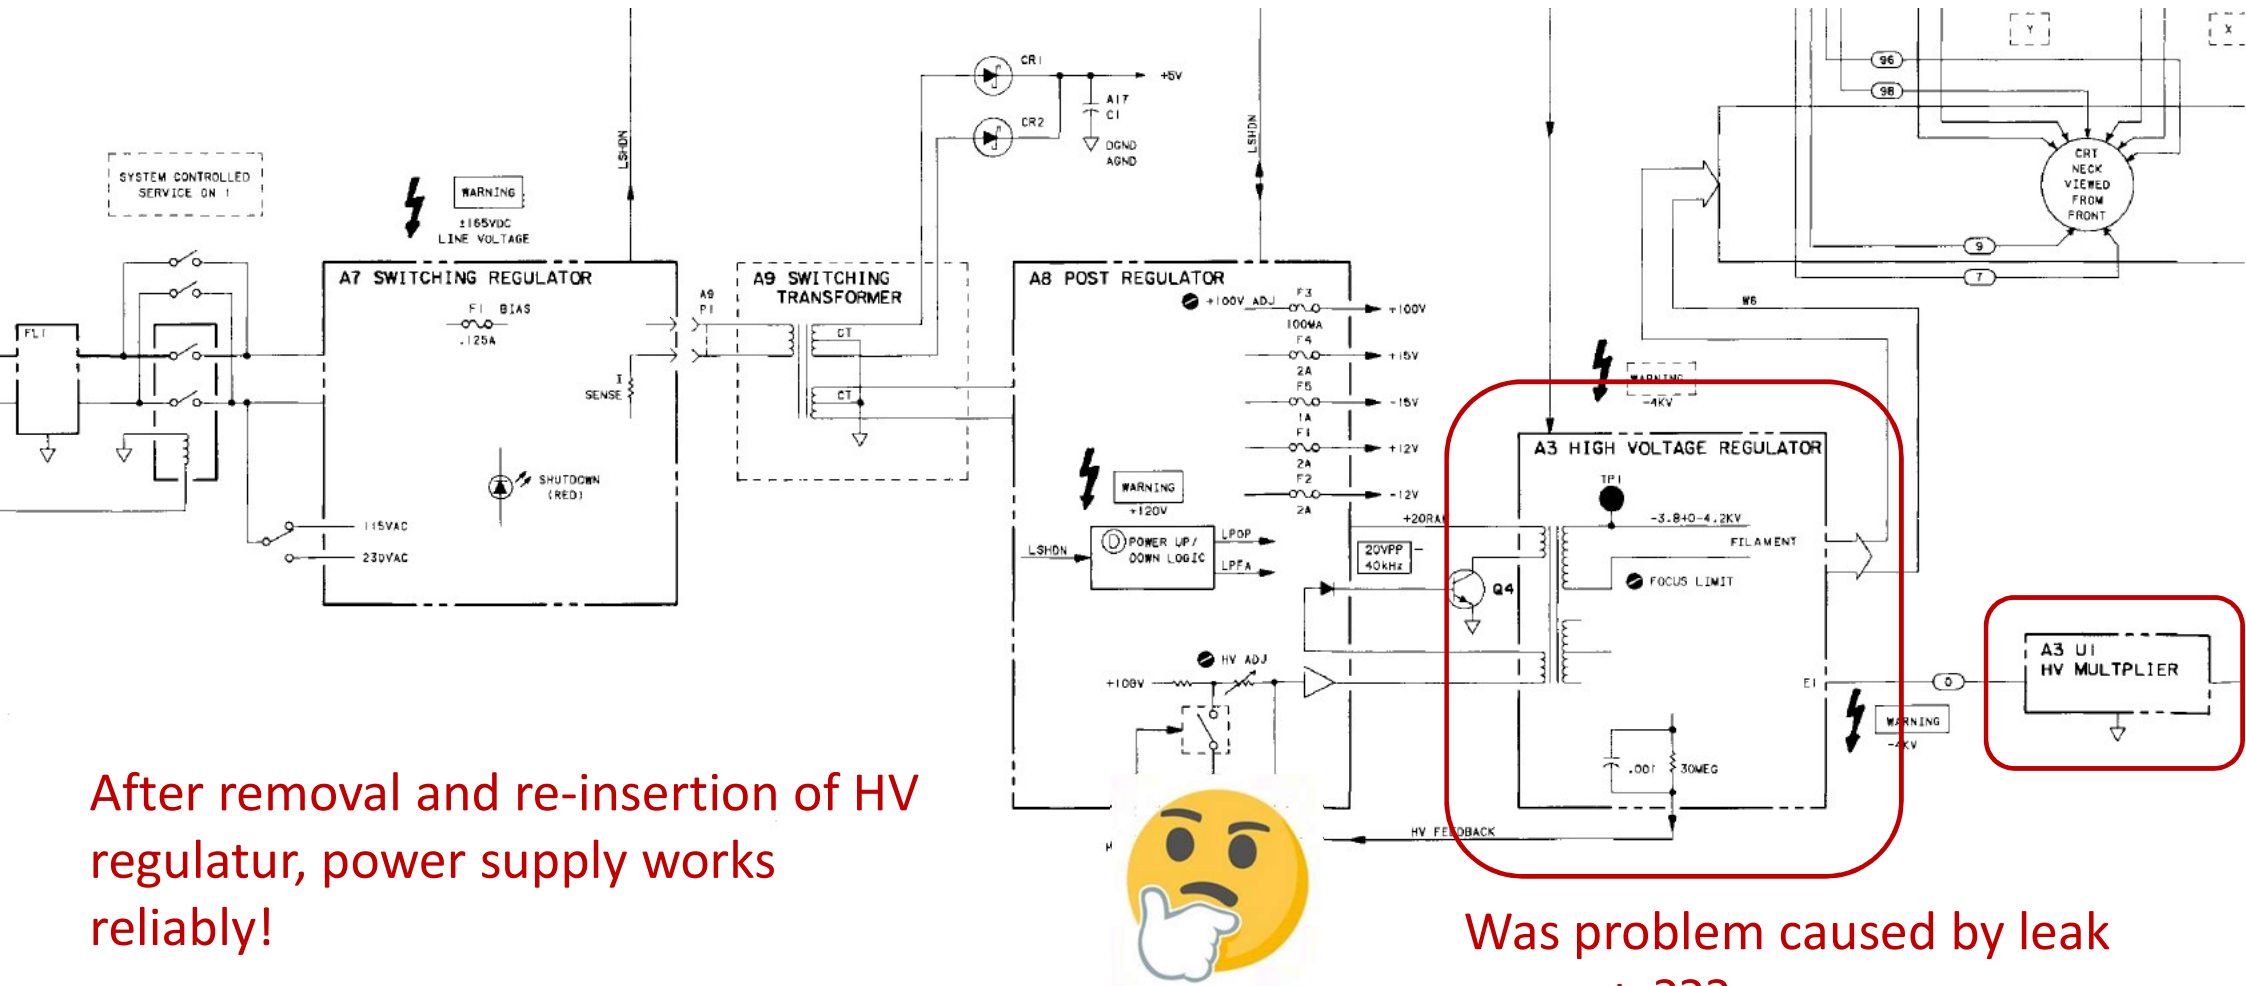
June 2022: HP85101 Power Supply 2nd Try

After removal and re-insertion of HV regulator, power supply works reliably!

Was problem caused by leak currents???

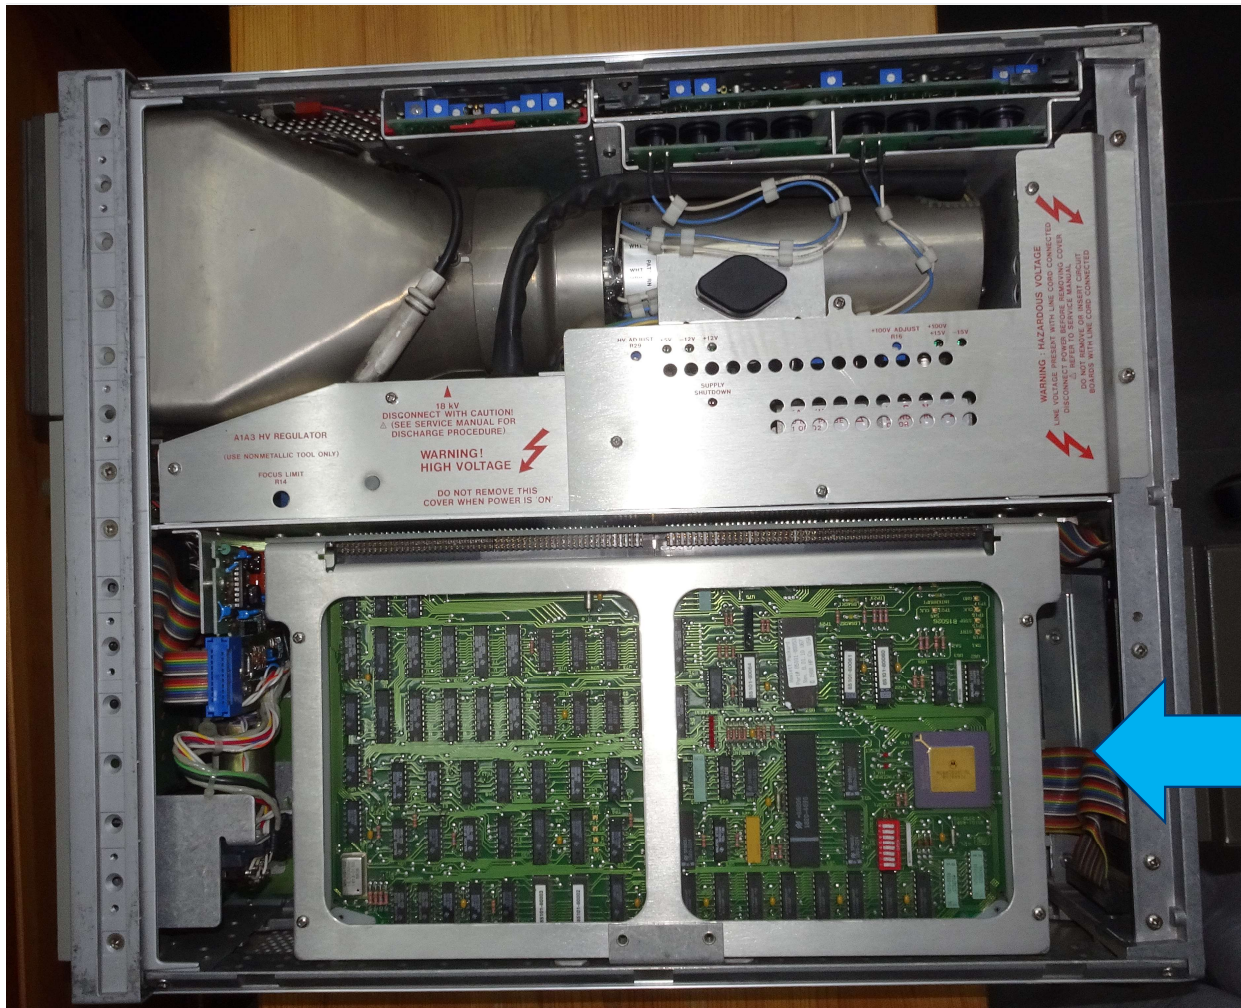
A stupid Mistake...

Where is board A15?
One of those,
But which one?

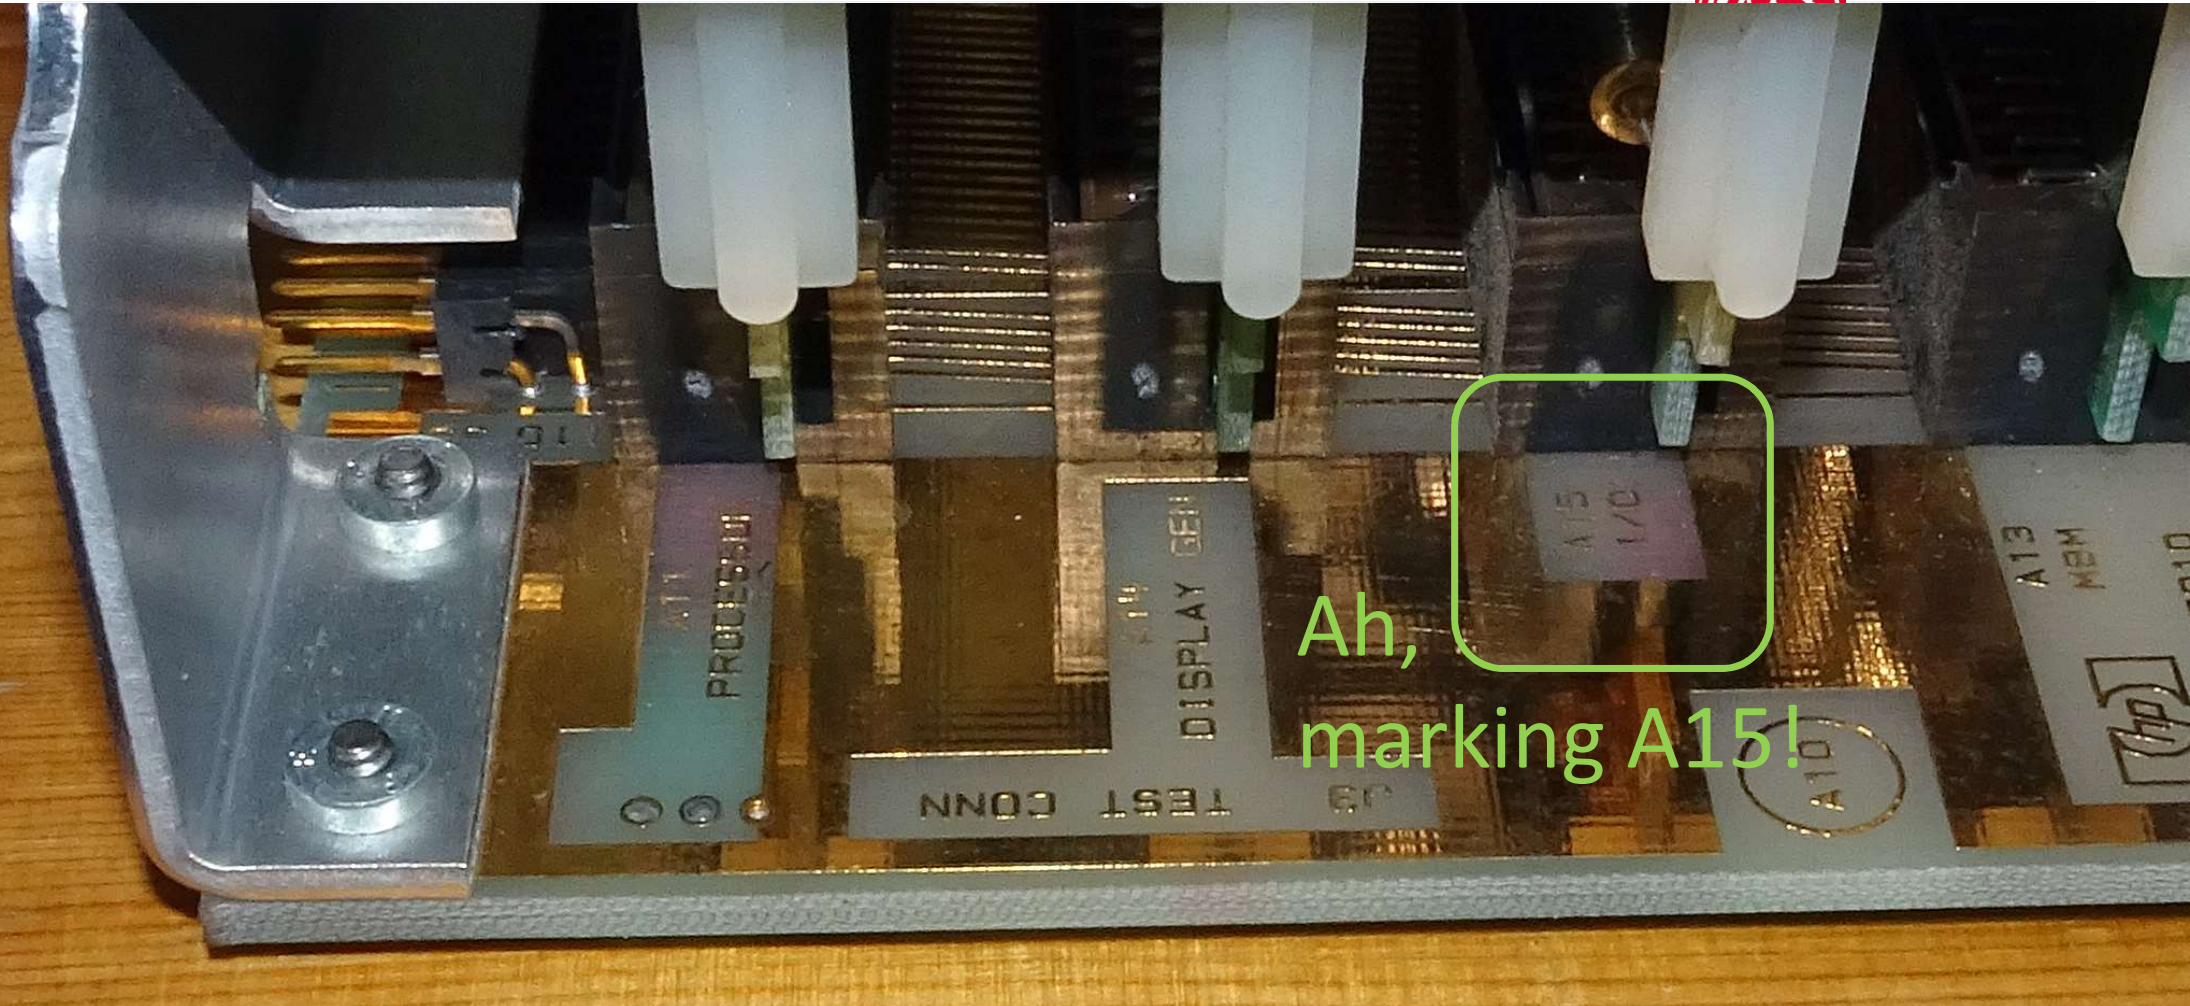
Ah,
marking A15!

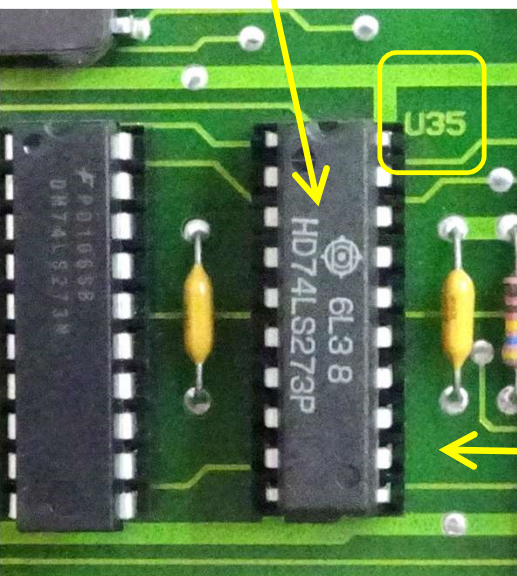
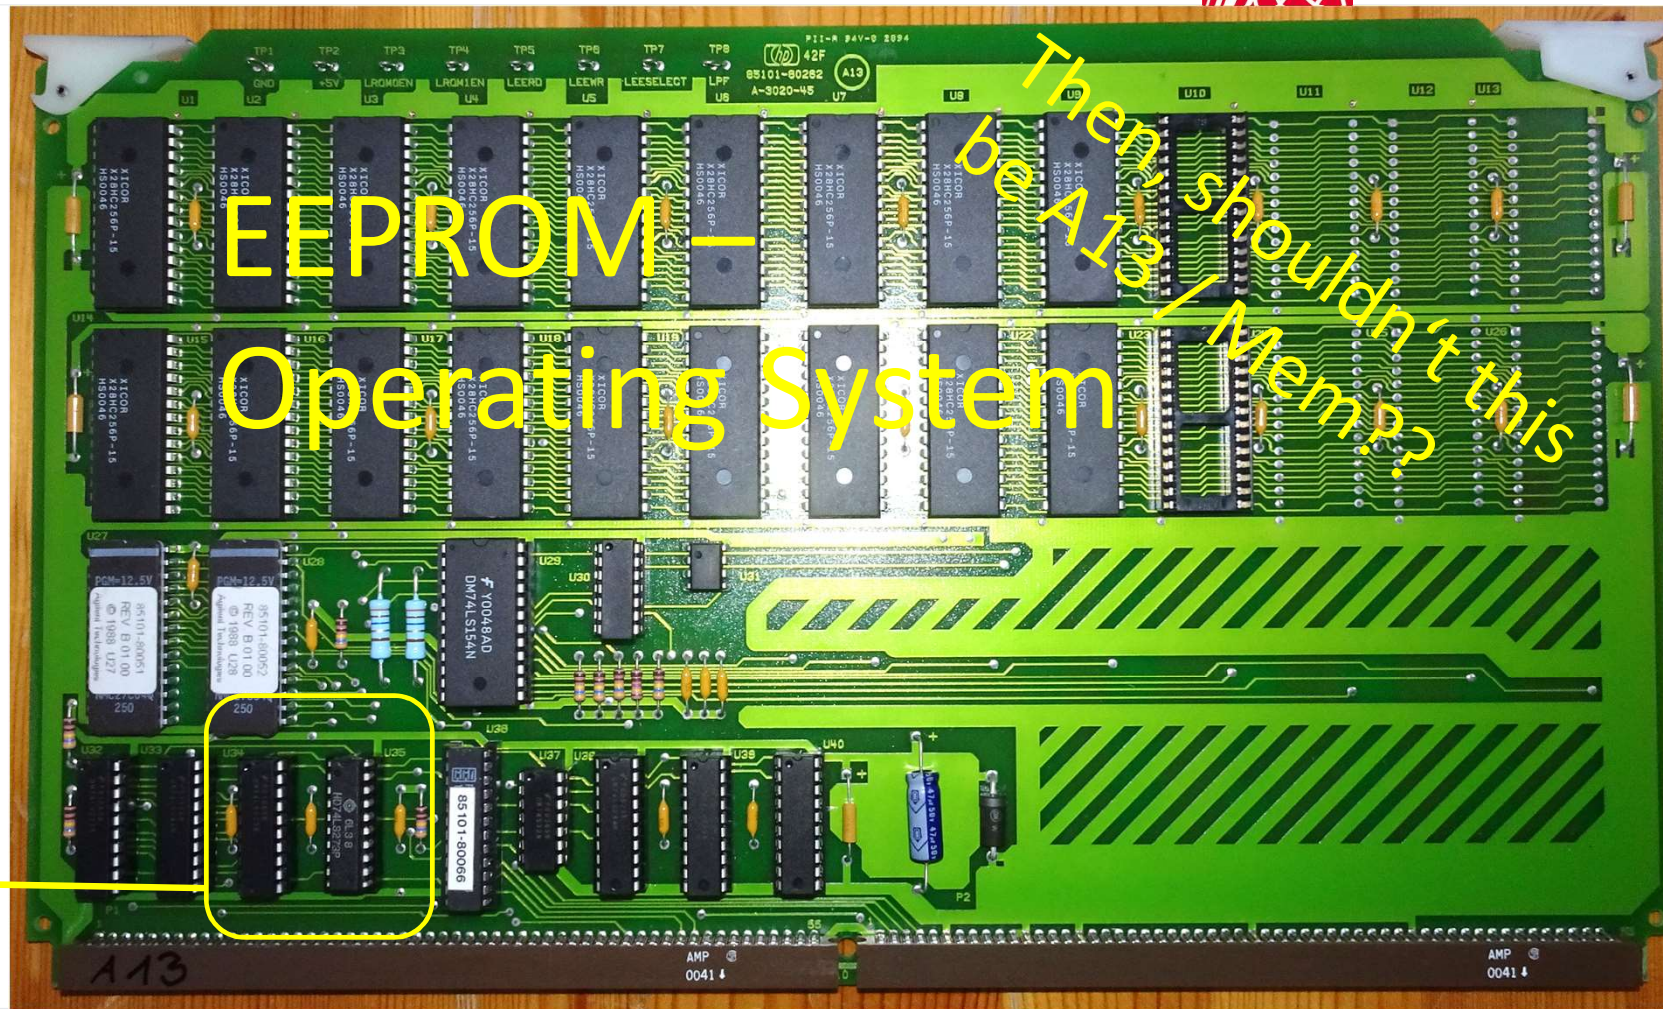
U35?
Ah, it has a socket!
No HP-part
number???

Board was mis-placed in Cage!

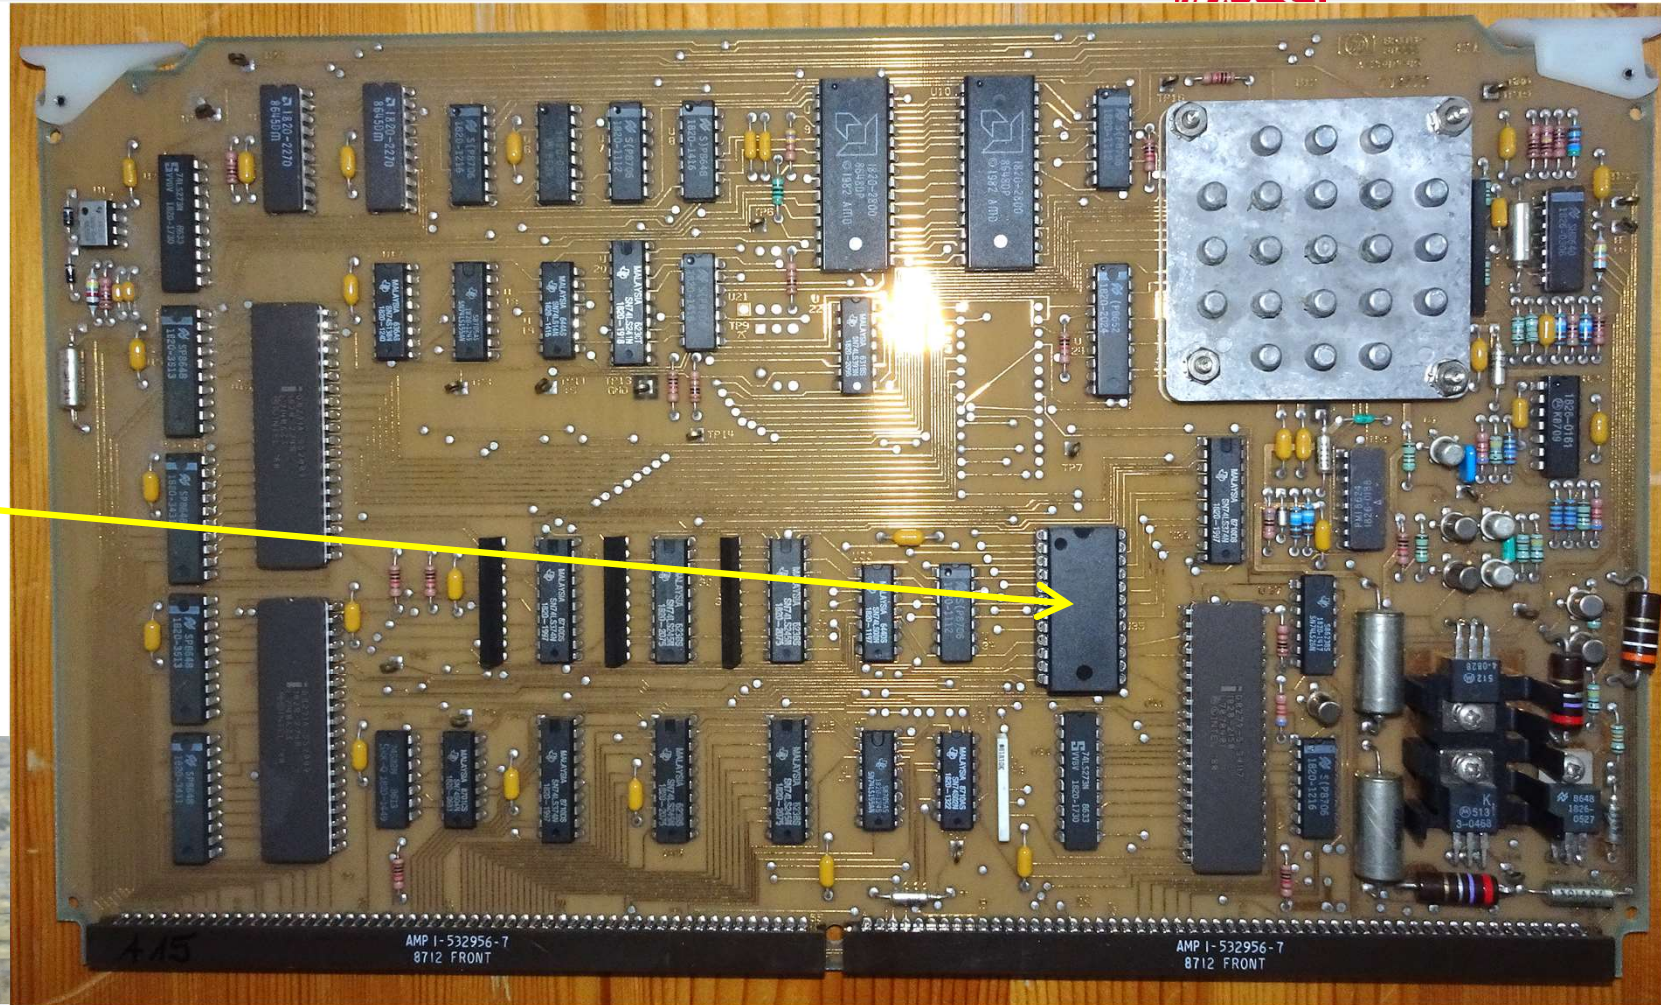
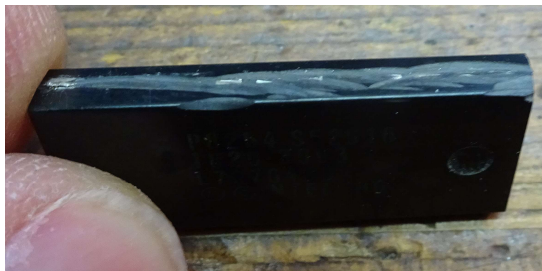
The „real“ A15 board !
And defective U35, an Intel Timer-IC, didn't have a socket

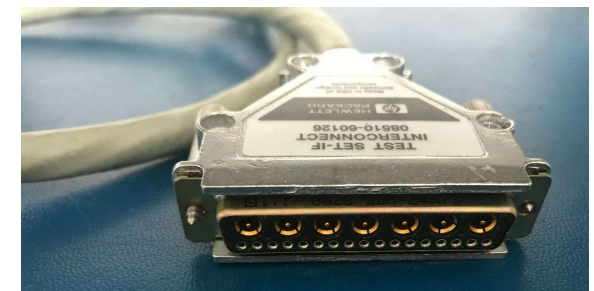
THE MOST LIKELY CAUSES FOR THIS FAILURE ARE:  
1. 85102 INTERCONNECT CABLE MISSING OR DAMAGED.  
2. 85102 A24 FAILURE.  
3. A15 I/O BOARD FAILURE.  
4. 85102 A0 FAILURE.  
5. 85102 MOTHERBOARD OR CONNECTOR OR CABLE FAILURE.  
6. 85101 A17 MOTHERBOARD OR CONNECTOR FAILURE.

Need interconnect cables!

Homebrew Interconnect Cables

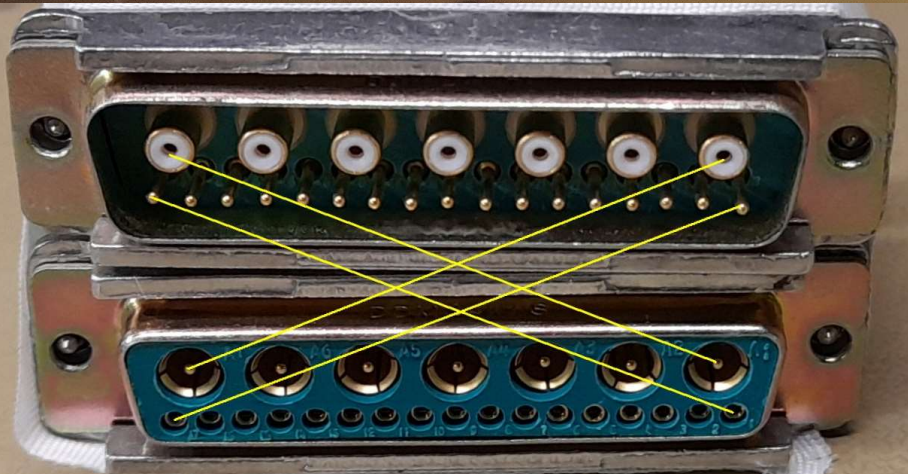
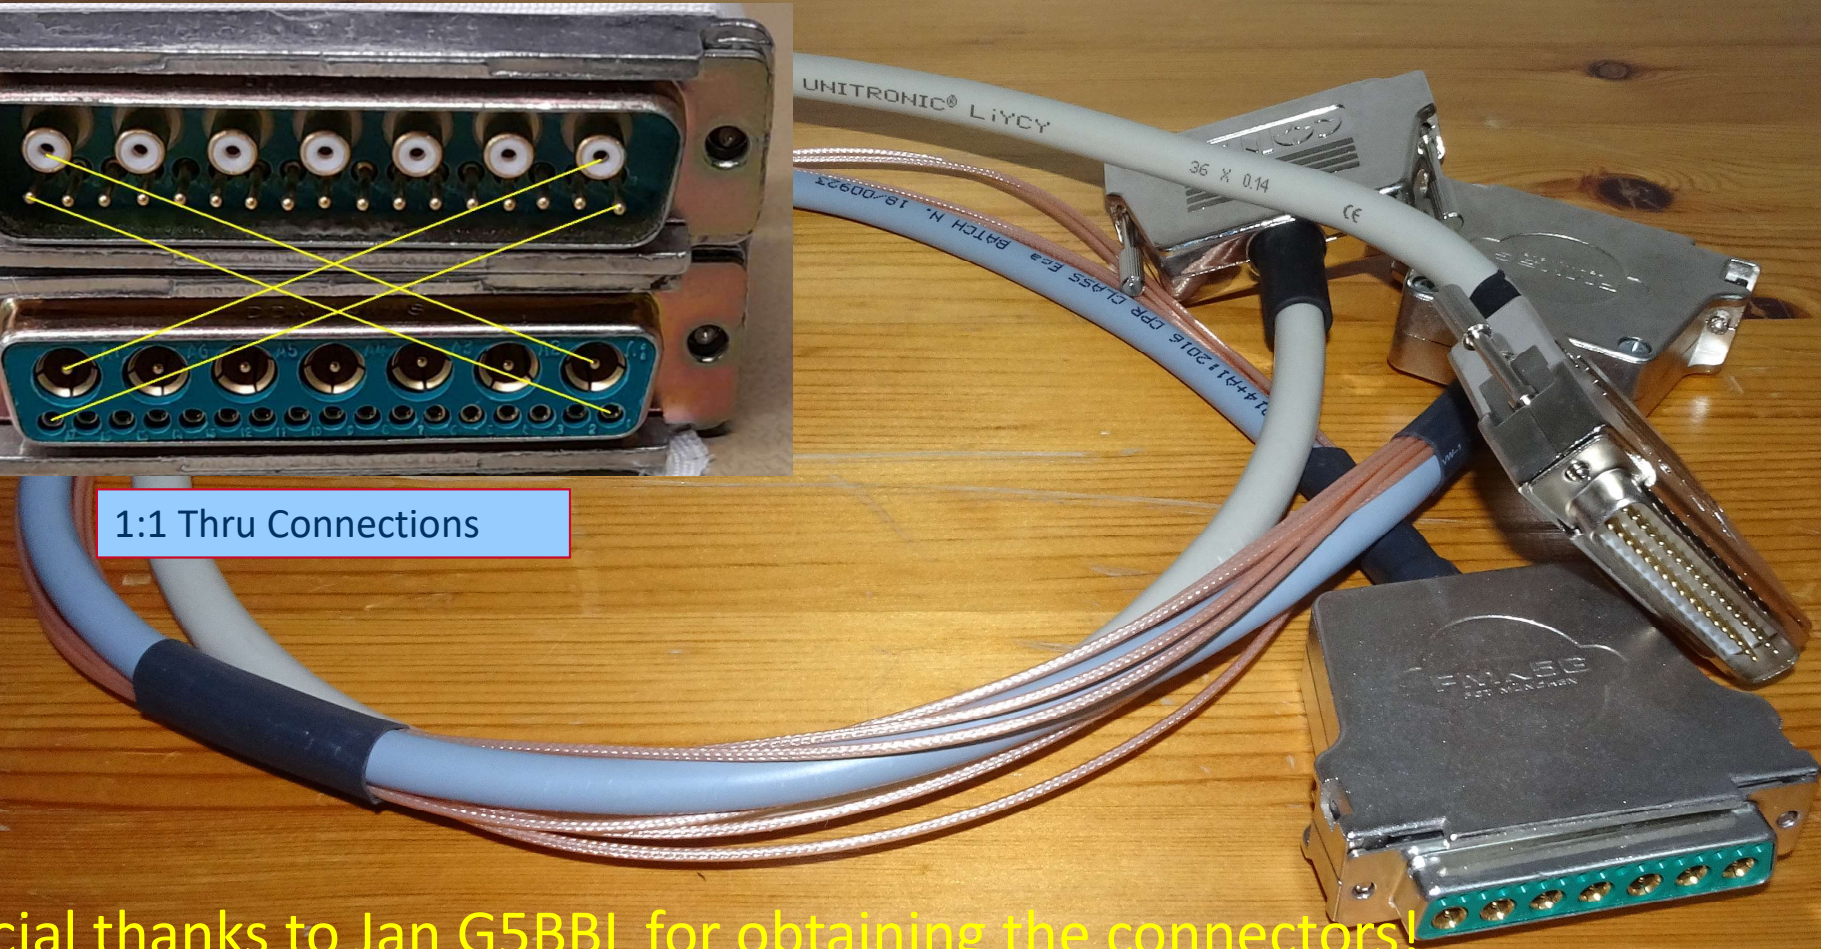
1:1 Thru Connections

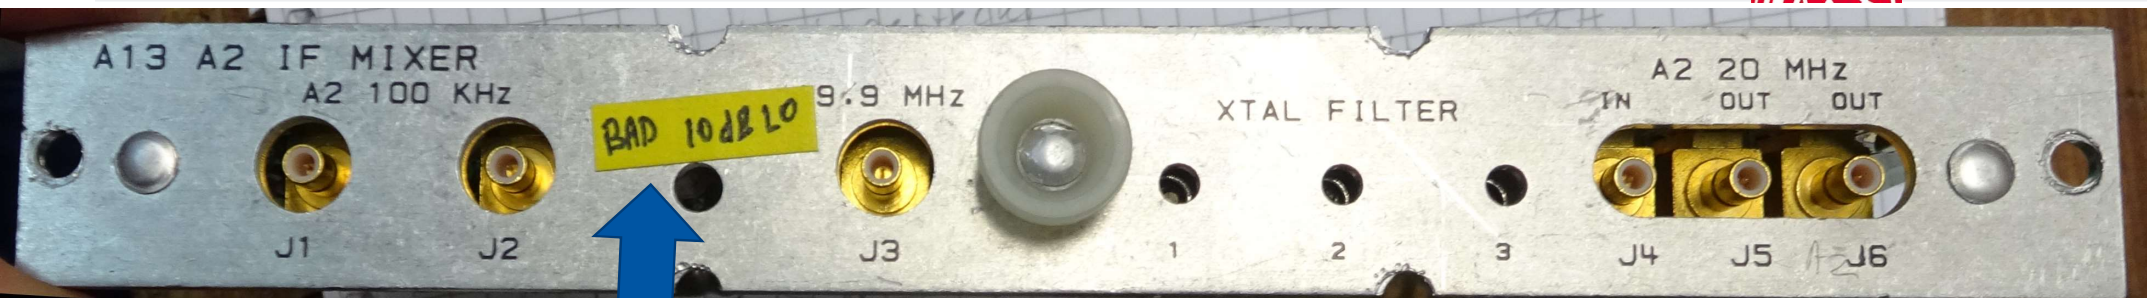
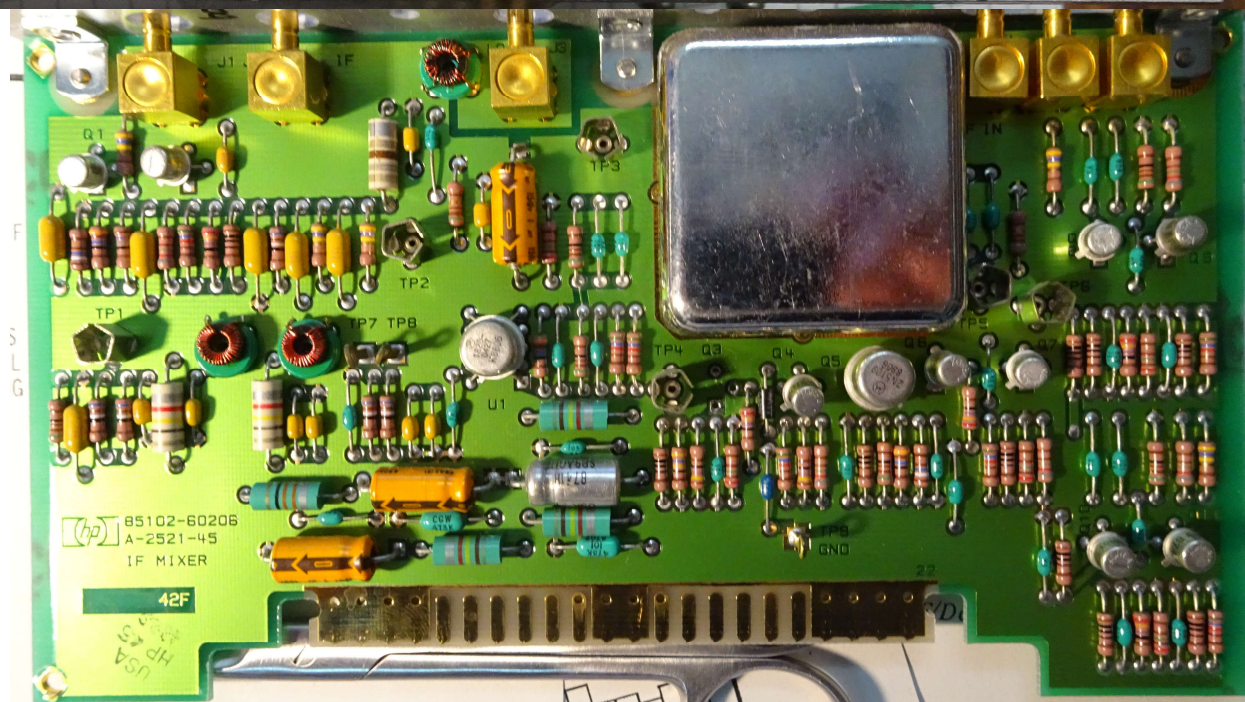
HP85102 IF Unit

Someone else had already messed around with this!
Two „bad“ stickers and loose coax cables!

Two of four IF mixers show too low levels!
