Adventure Microwave-VNA: Repairing and Operating an HP8510

Prof. Dr. Thomas Baier
DG8SAQ

My Deram: HP8510 – 26,5GHz VNA

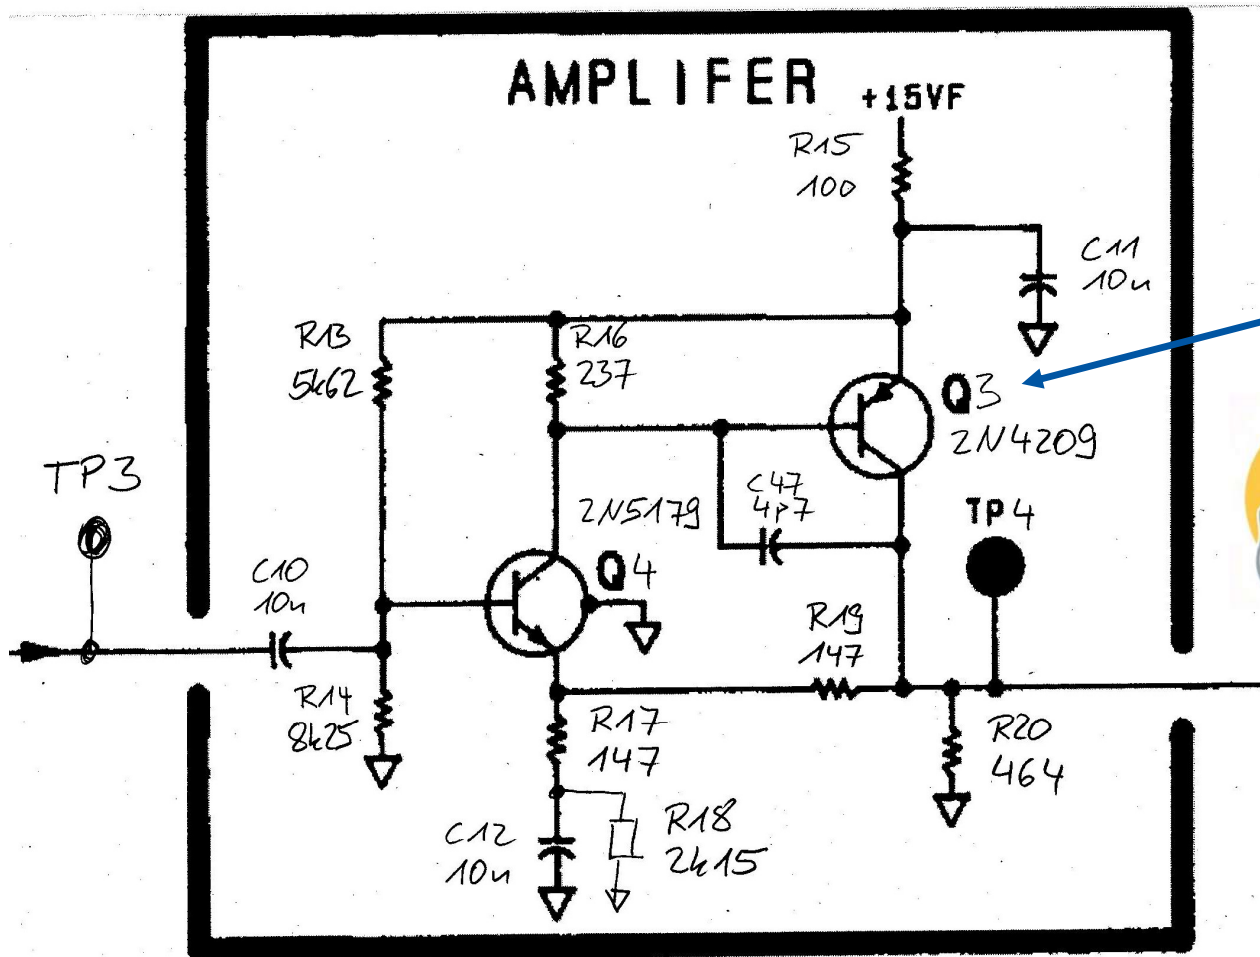
HP85102 IF-Mixer Reverse Engineering ...

Standard Gain Block

- dc-levels unsuspecting
- 6dB higher gain after replacement of PNP transistor!

All PNP transistors on all mixer boards replaced!

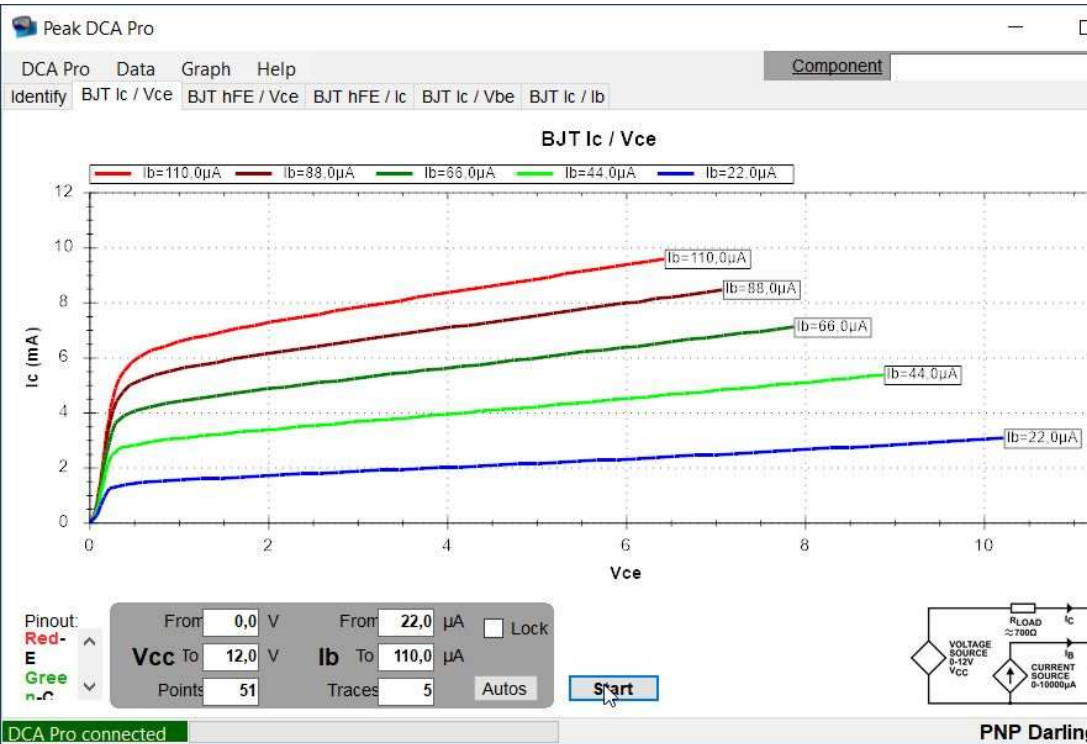
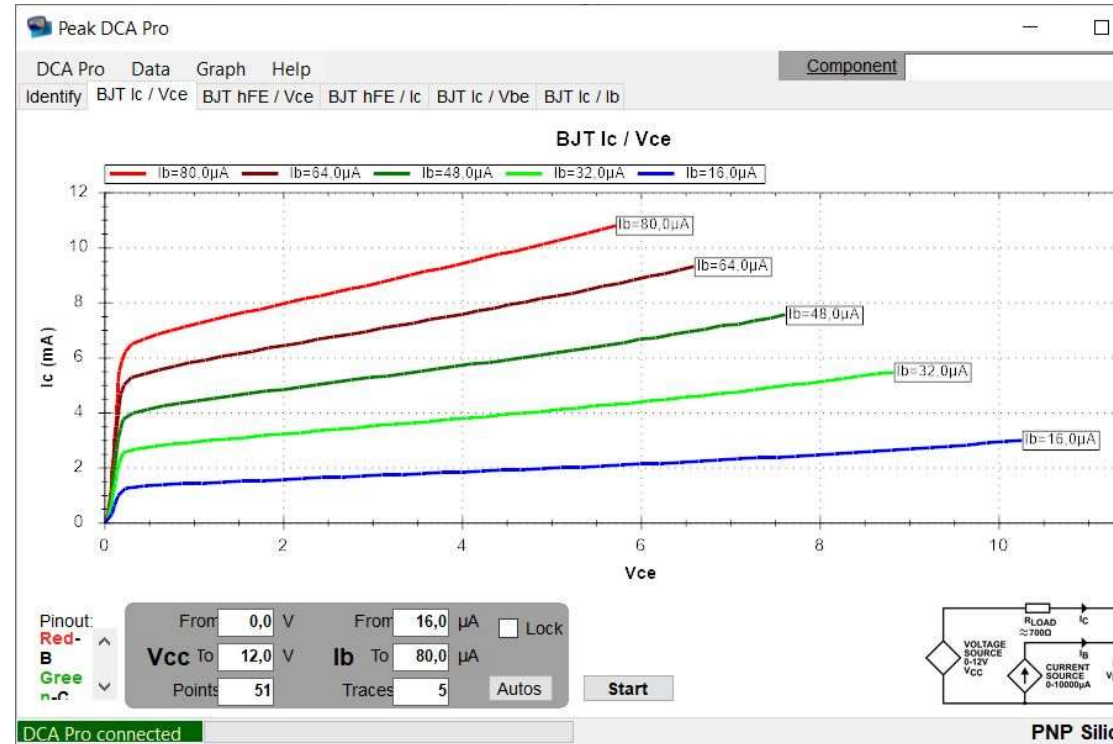
2N4209 PNP Transistors

BAD

GOOD

Slightly different current gains

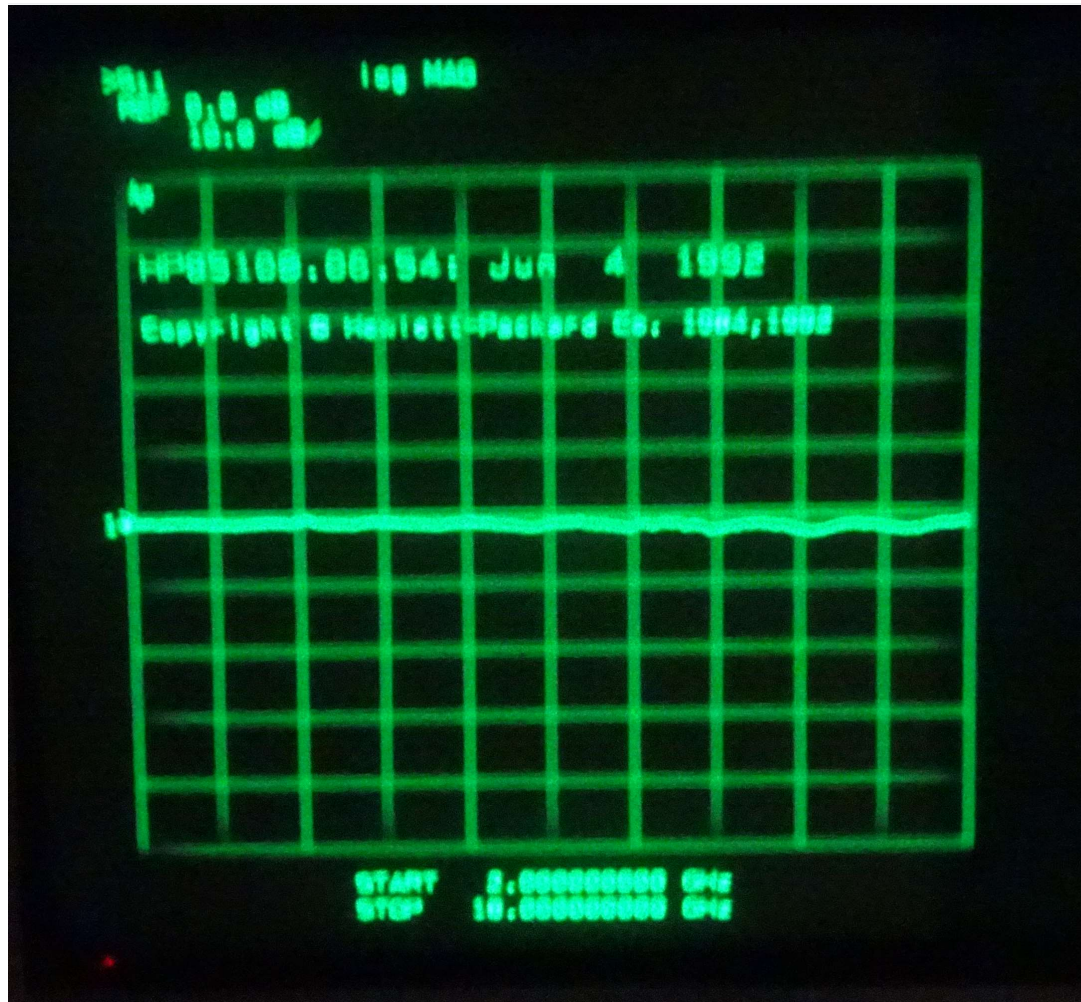
Sign of Live

- Display unit technically ok
- IF unit operational
- Test set operational

Screen image either fairly bright OR crisp but never both at the same time
⇒ CRT wants to be regenerated, see <http://www.ke5fx.com/crt.html>

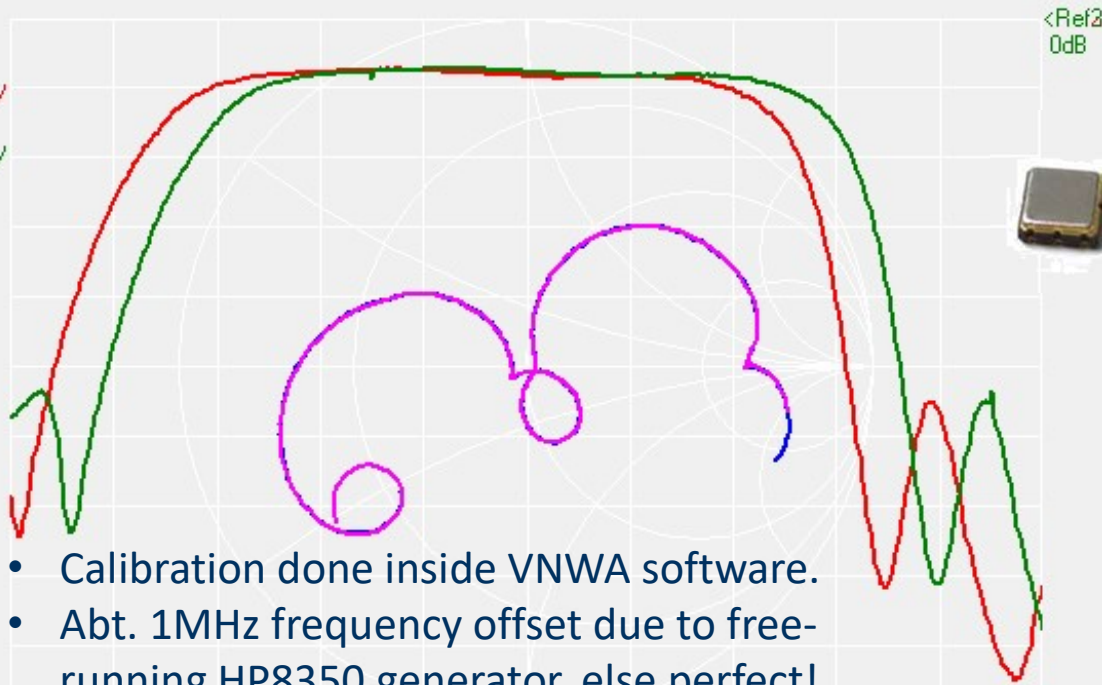
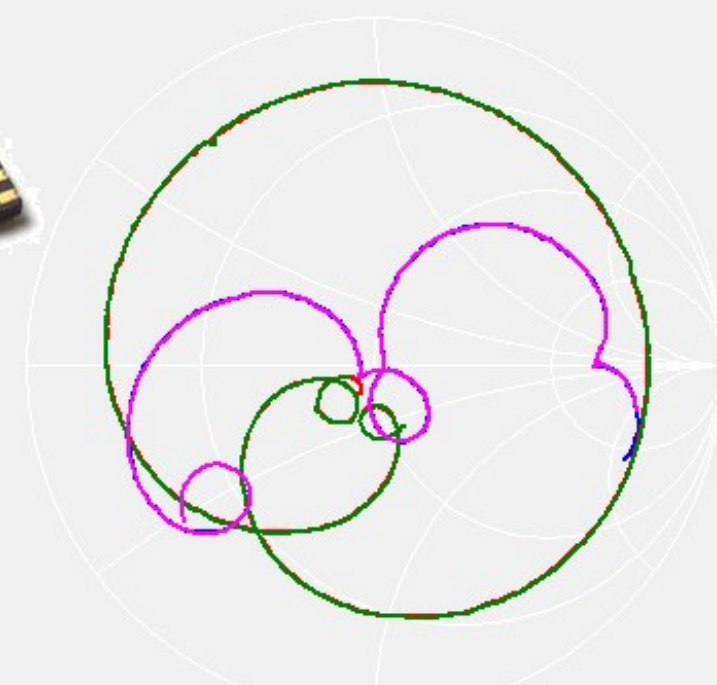
First Test: HP8510B vs. DG8SAQ VNWA3

02.11.2022 07:55:28 435MHz SAW: Sij: HP8510B, Plot*: VNWA3SE, Rosenberger cal kit

- Calibration done inside VNWA software.
- Abt. 1MHz frequency offset due to free-running HP8350 generator, else perfect!

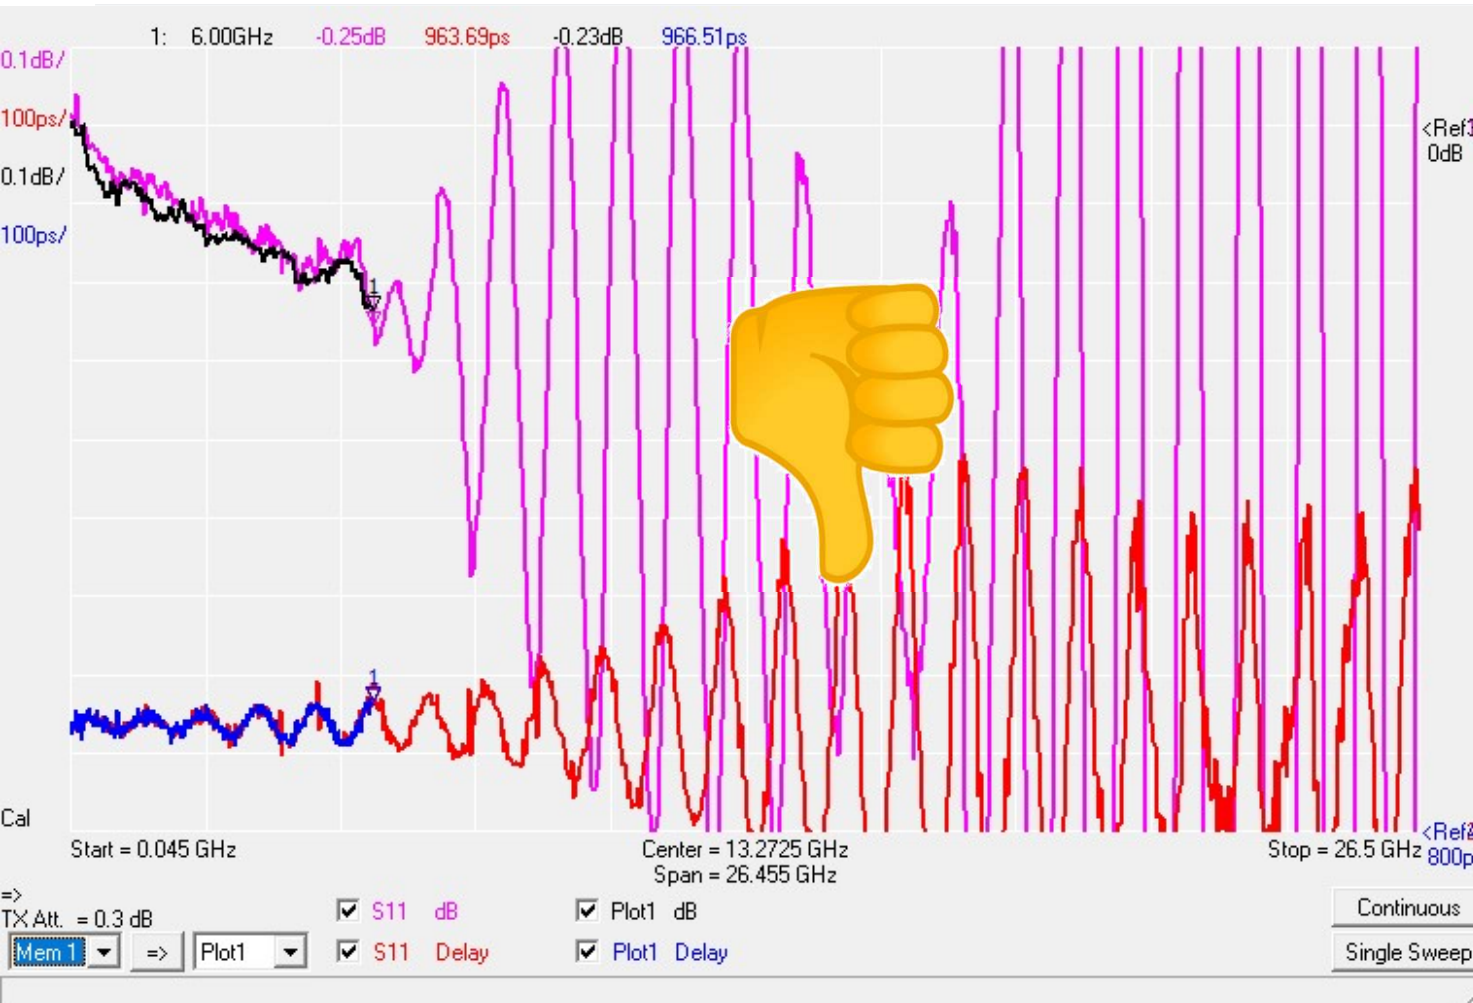
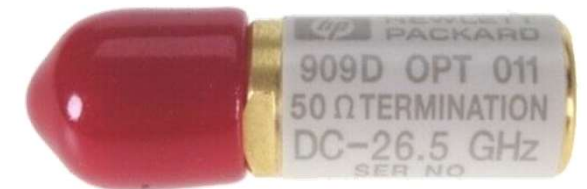
Extrapolation of Calibration to 26,5 GHz (1)

Problem: HP909D Load:

- Extrapolation invalid above 6GHz.
- Above 6GHz no load data available.
- HP8510 Cal Kits assume Load as *ideal!*

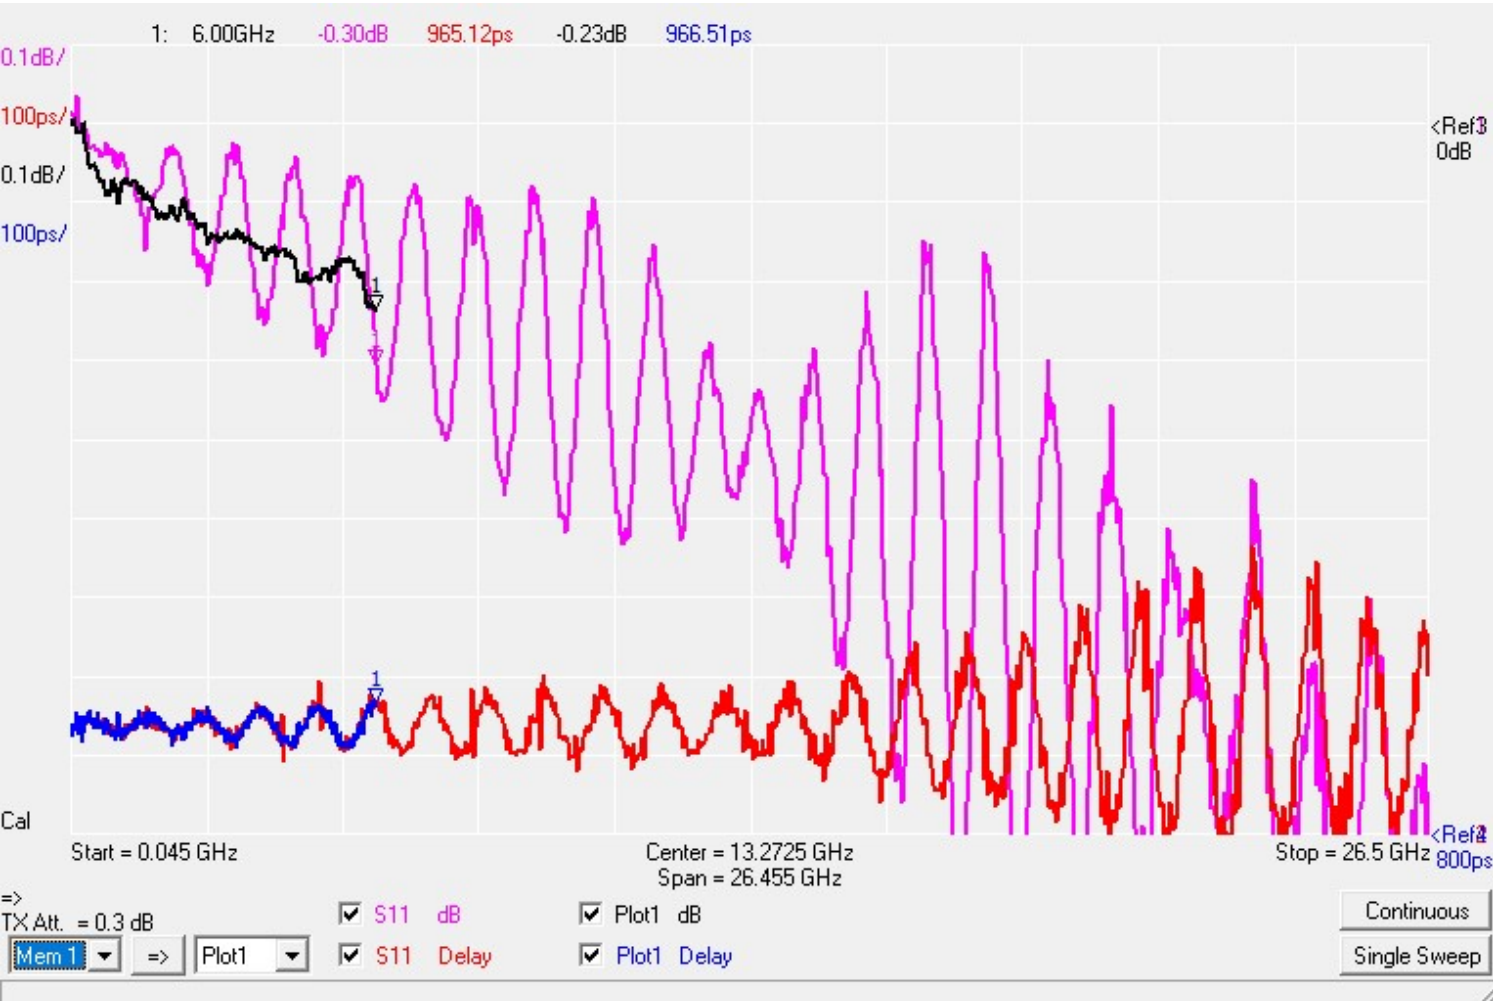
Extrapolation of Calibration to 26,5 GHz (2)

Ideal load assumed:

S=0

- Worse below 6GHz
- Better above 6GHz

- *HP909D should be compared to a good commercial cal-kit.*
- *An air-line would make a superior DUT.*

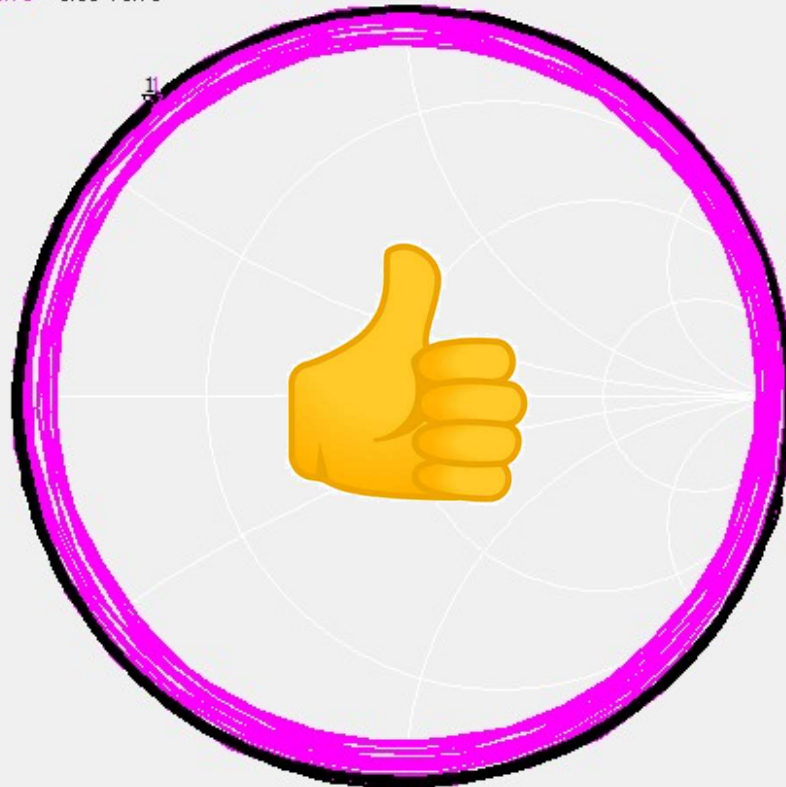
Extrapolation of Calibration to 26,5 GHz (3)

1: 6.00GHz -0.64+i0.73 -0.65+i0.73

- We are talking about an error of $\pm 0,3dB$ for a highly reflecting DUT up to 26,5GHz!
- Error hardly noticable in Smith-chart.

Quite satisfactory for hobby use!
